Altamont Sector Stormwater Management Program 2025 Annual Report

**California Department of Parks and Recreation
Diablo Range District
15751 Tesla Road
Livermore, CA 94550-9364**

Date: February 2026

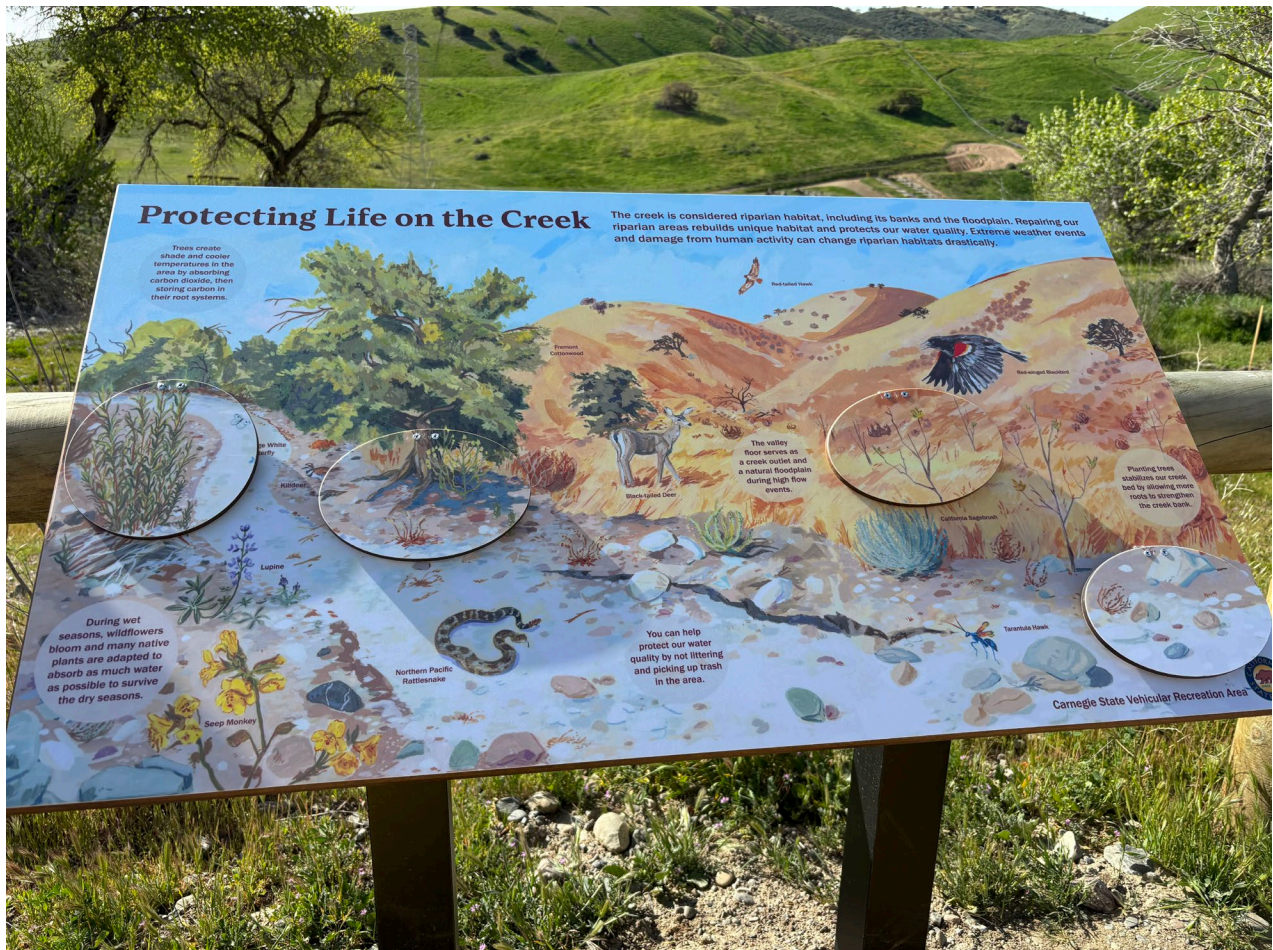
Figure 2-4: New riparian area interpretive panel.

In Year 12, staff installed a riparian area panel that describes how park staff are working to restore Corral Hollow Creek and what park visitors can do to continue to protect it (Figure 2-4). The panel

includes a watercolor painting of the riparian area and explains how native plants and animals use the creek. The panel is interactive with flaps that visitors can lift to see what is happening underground in the riparian area.

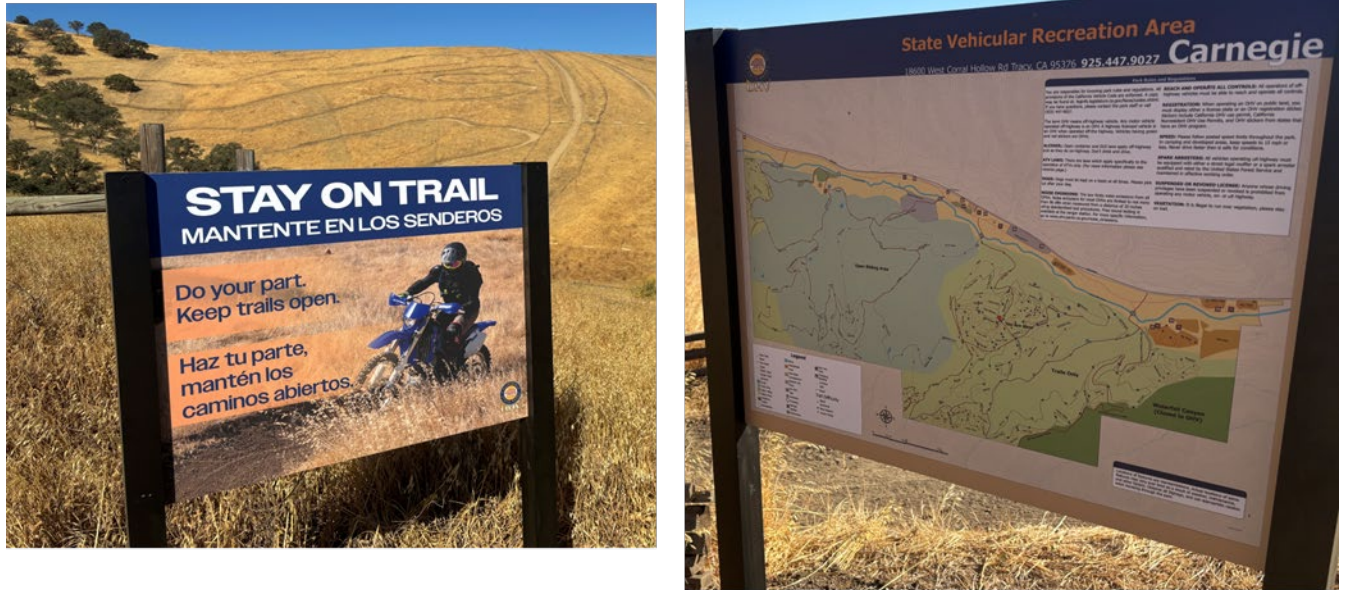
Figure 2-5: New double-sided “Stay on Trail” interpretive panel.

During Year 12, Altamont Sector staff created several double-sided "Stay on Trail" panels to be placed throughout various RMAs in the trail system in the hills (Figure 2-5). These panels were completed and delivered to Altamont Sector within this reporting period. The new panels will be installed in Year 13. They will direct users to Stay on Trail in both English and Spanish, and the back side of the panel includes a map of Carnegie SVRA with a locator to show riders where they are currently located in the park.

Additional panels with the same design will be created and installed in subsequent program years as a continued effort to increase public awareness of the importance of recreating on trail while in RMAs to protect park resources.

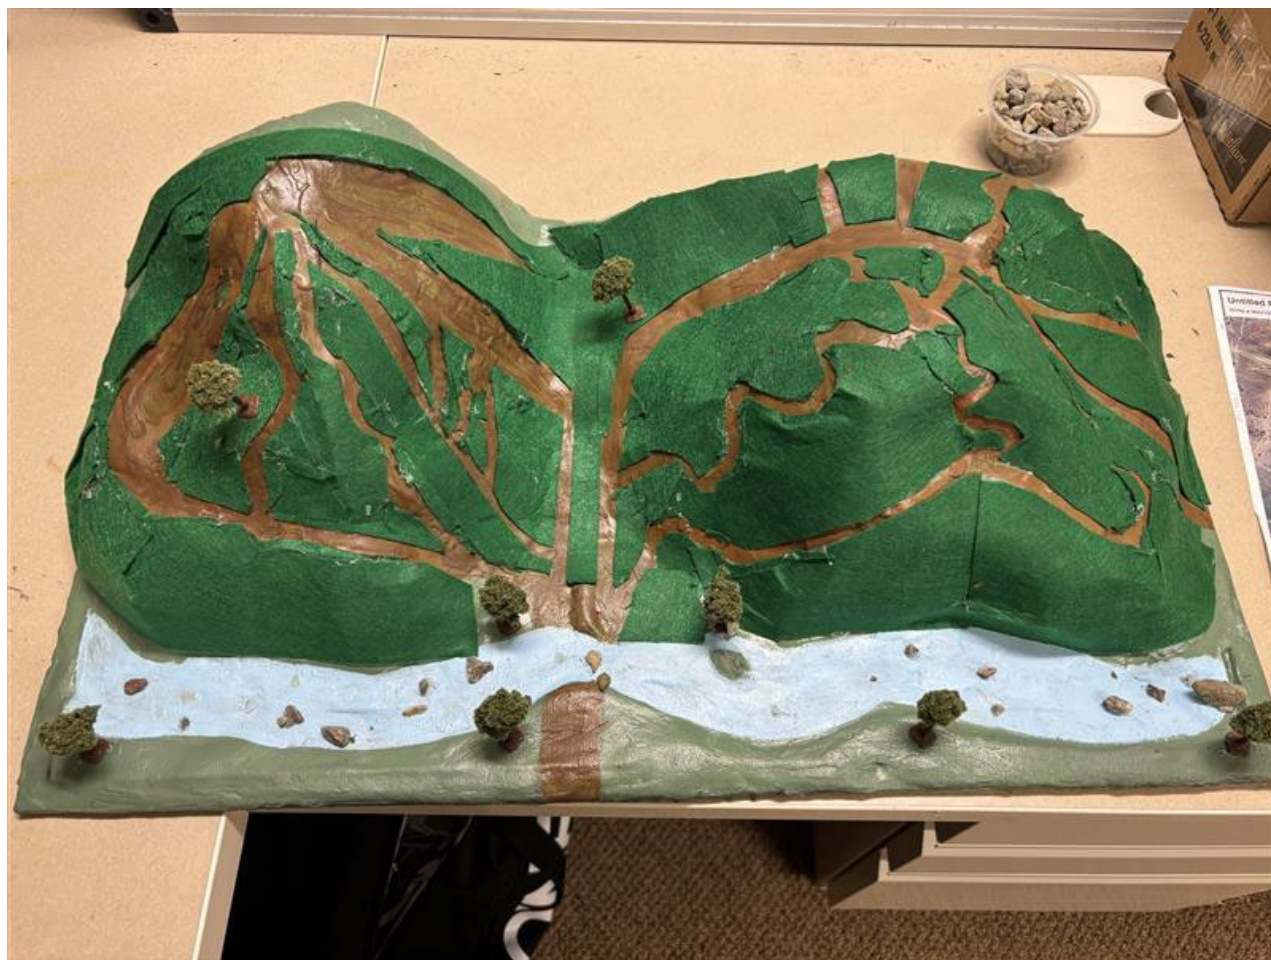
Figure 2-8: Watershed model that was completed in Year 12.

The Altamont Sector Interpreter is constantly developing new and creative ways to effectively inform SVRA visitors of SWMP elements. In Year 9, the Altamont Sector Interpreter constructed an erosion box to demonstrate how vegetation helps keep sediment in place and captures it as it erodes, which helps reduce the amount of sediment that ends up in a receiving water body. During this reporting period, the Interpreter obtained a model of the Corral Hollow Creek Watershed to use for future demonstrations (Figure 2-8). Having this watershed model will allow the Altamont Sector Interpreter to present SVRA visitors with visual examples of how processes in the watershed can be influenced by illicit discharges or illegal dumping, as well as how these things can affect recreational opportunities at Carnegie SVRA. The watershed model was completed in May 2025 during the Year 12 reporting period. The Sector Interpreter is planning Junior Rangers activities that will put the watershed model to use for Year 13.

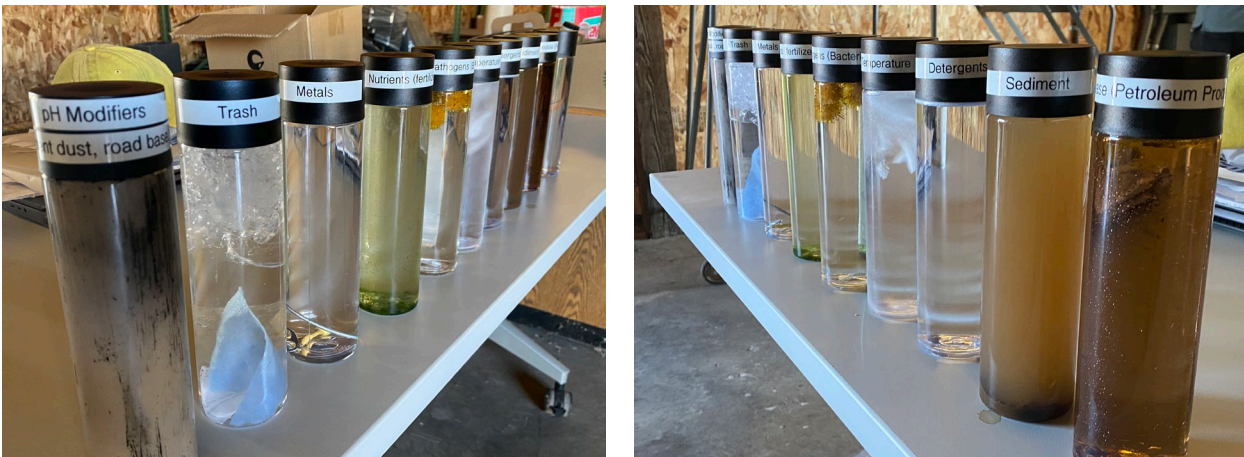
Figure 2-12: Contained samples of common stormwater pollutants.

In Year 11, Michael Baker International and Division Park staff set out to identify opportunities to make the stormwater training an even more enjoyable process by improving training activities and increasing excitement, access, and participation. In addition to competitive games such as Stormwater Bingo, hands-on activities were also included to enhance the attendees' understanding of potential stormwater pollutants and required IDDE procedures. Additionally, contained samples of common stormwater pollutants were created to show attendees what to look for when identifying potential illicit discharges (Figure 2-10).

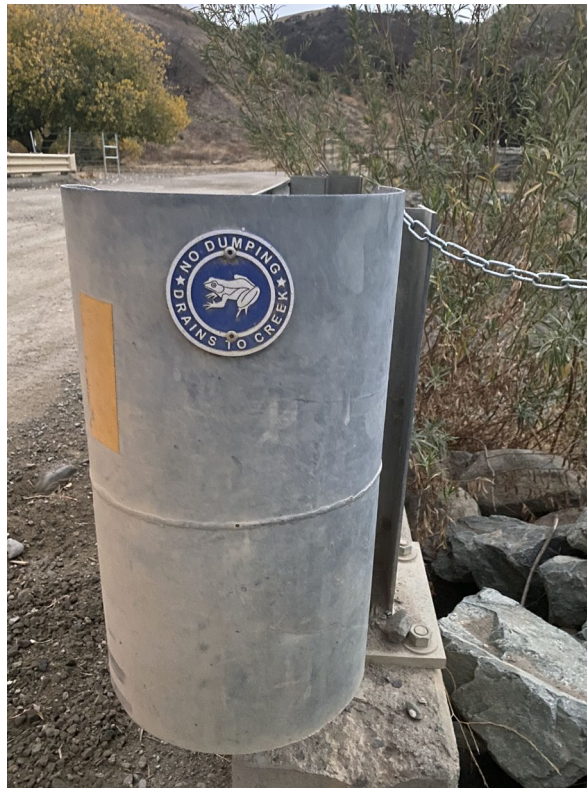
Figure 2-16: Example of installed storm drain marker.

In an effort to help prevent future illicit discharges, an IDDE information panel was created and is included in Appendix B. These information panels have been posted in areas where visitors commonly congregate, such as near the park store and on the campground ramadas. The IDDE information panel is currently posted near the entrance to the trail system at Los Osos and Carrol Canyon. This IDDE panel will be updated in a future reporting period. Educational brochures, discussed in Section 2.1.2, and interpretive panels, discussed in Section 2.1.3, are used to convey how visitors can help keep the Altamont Sector in compliance by reporting illegal dumping and maintaining OHVs to eliminate potential pollutants. These brochures are distributed to SVRA visitors at events and at the entrance kiosk. Storm drain markers have been installed throughout the park to remind visitors of the park's policy on illicit discharges: "No Dumping – Drains to Creek". These storm drain markers are imprinted with some of the wildlife species that benefit from park users and staff working to prevent illicit discharges from entering the receiving waters of Corral Hollow Creek.

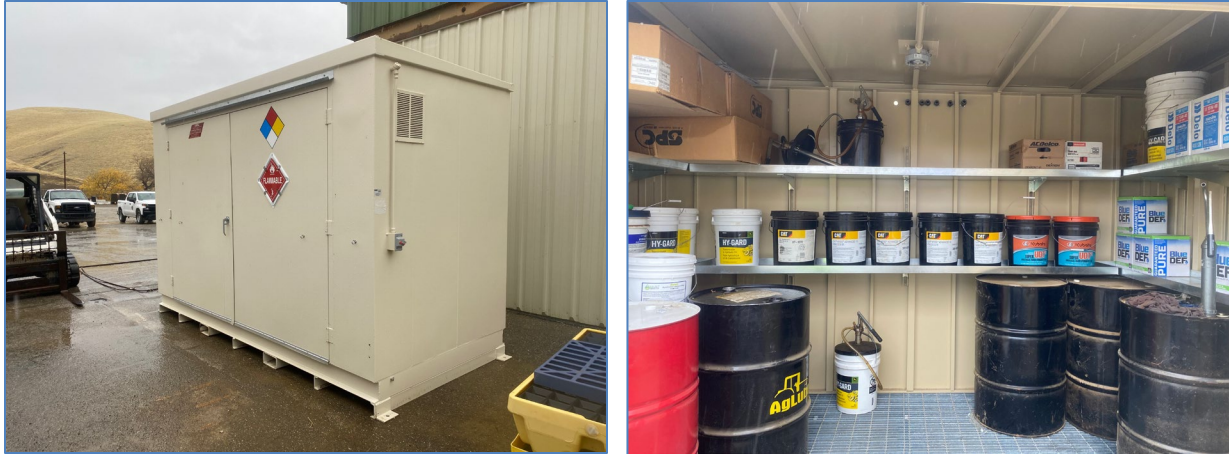
Figure 2-17: Oil containment system in the Carnegie SVRA Maintenance Yard.

In Year 10, park staff installed a new oil containment system outside of the Carnegie SVRA maintenance shop. Prior to this new system, oil was stored on a large yellow spill containment system in the shop behind the mechanic's toolbox. The new oil containment building is fireproof with its own spill containment system. This building can store several 55-gallon drums of oil with connections to a pneumatic air system that delivers oil into the shop through a hose. This new oil containment system creates more space within the Carnegie SVRA maintenance shop and has made adding fluids to vehicles for equipment servicing much easier while also reducing the chance of a potential oil spill in the shop since oil is no longer stored inside. The system also allows used oil and fluids to be sucked back through the same system and funnels the used oil back into a 55-gallon drum. The current contractor, American Valley Waste Oil, collects the oil once the drums are filled. Sector maintenance staff then switch out the drums of oil when they are emptied and hook the air system up to a new container of oil.

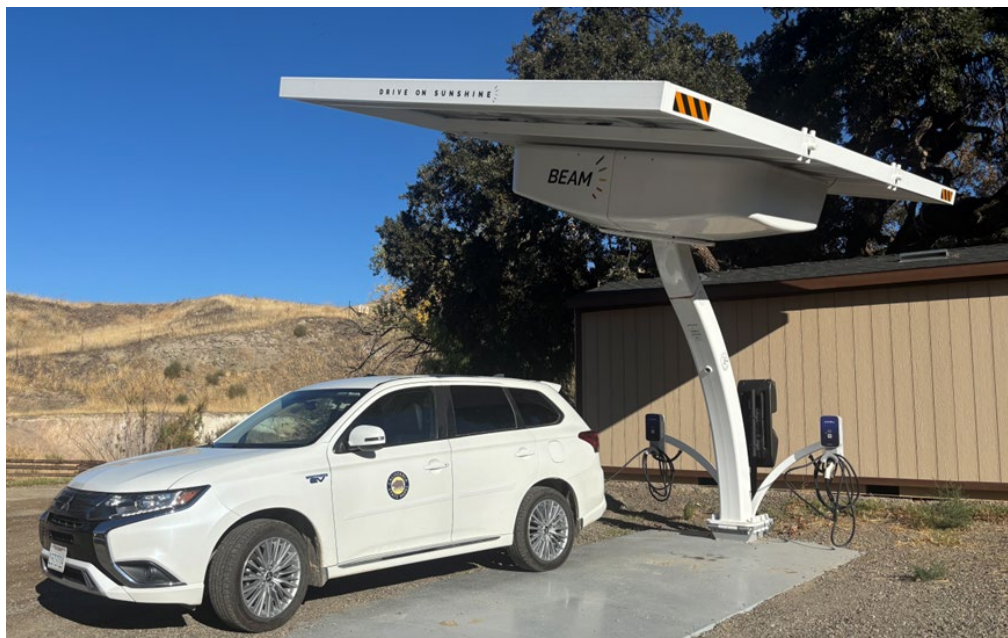
Figure 2-18: BEAM Global EV charger at the Altamont Sector office.

An electric vehicle (EV) charging station was installed during the 2018 reporting period to provide for the emerging electric motorcycle market and the riders that use them in the park. Several charging stations were also installed near the Diablo Range District Office down the road from the park in 2020. In 2022, an updated EV charging system was installed at the park entrance that now services two vehicles on a trickle charge (Figure 2-18). During this reporting period, a solar charging station was donated by BEAM Global to be stationed at the Altamont Sector office for both staff and public use. Visitors may access this charging station while at the park for no additional cost. Altamont Sector staff are currently exploring other areas within Carnegie SVRA where an EV charging station can be installed.

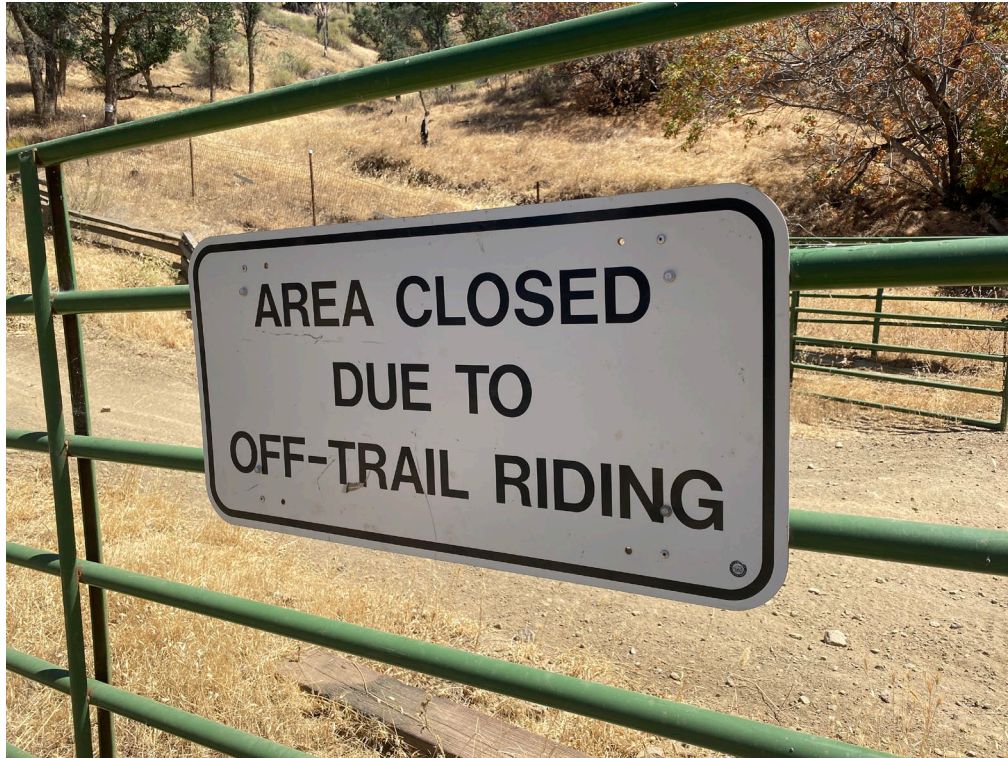
Figure 2-23: Example of signage used for trail closures due to off-trail riding.

The most innovative approach to the trails program has been a redesign of the methods used to protect the trails and rehabilitated areas. In the past, drift fencing was the primary tool to keep riders on designated trails. This method was re-evaluated and updated so that each rehabilitated RMA is now surrounded by perimeter fencing with access gates at the entry points. If voluntary trails are created, the access gates are closed for a predetermined amount of time to allow staff to make repairs and to reinforce the “trails only” message. The progress of this methodology is discussed in Section 3.2.

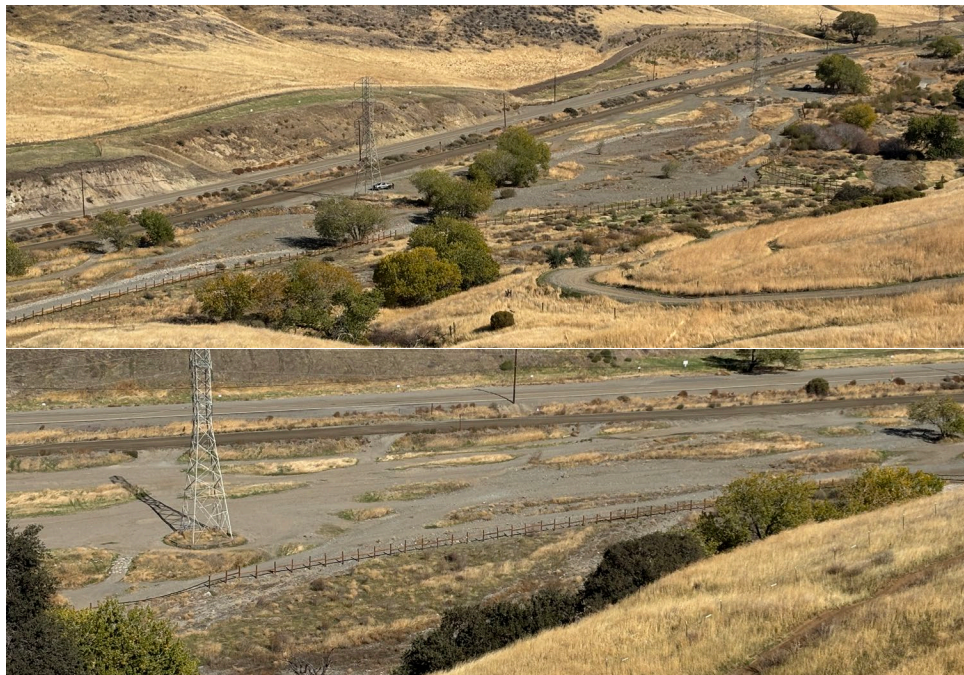
Figure 2-24: Completed creek delineation fencing at Corral Hollow Creek.

After the extensive damage from the 2023 storms, the delineation fencing to restrict OHVs from recreating in Corral Hollow Creek required thousands of feet of replacement or repair work. Altamont Sector staff decided to change the style of fencing used to block off the creek from split-rail fencing to peeler fencing, which will still prevent OHVs from recreating in the creek corridor while also allowing for variable flow for the creek along the valley floor, since the valley floor falls within the flood plain of Corral Hollow Creek. This effort began during the Year 10 reporting period and will continue until the creek delineation fencing throughout the approximately 4-mile length of the valley floor has been replaced. During this reporting period, the fencing on the west end of Carnegie SVRA was completed, totaling approximately 0.66 miles of fence (Figure 2-24).

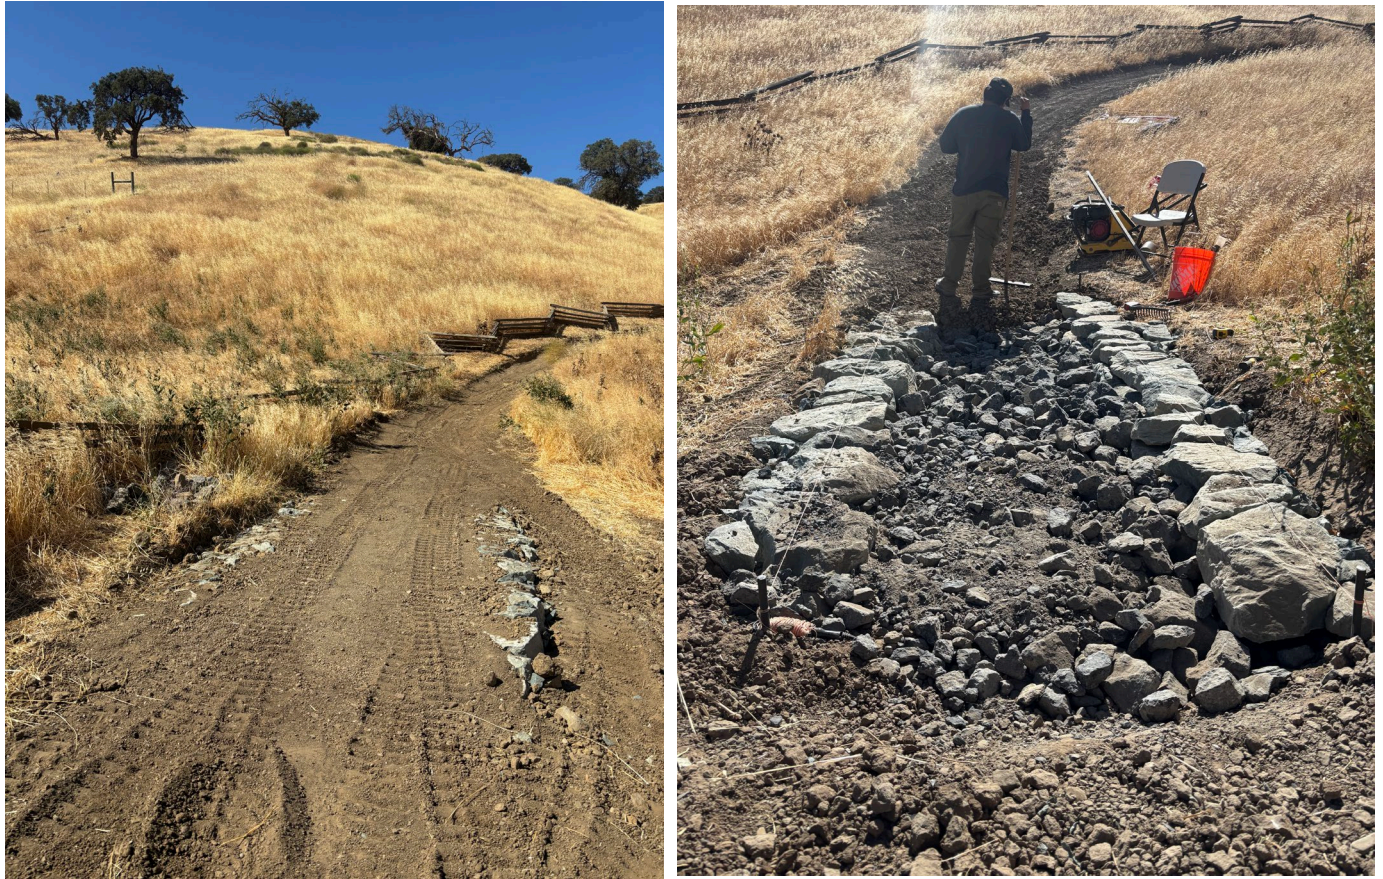
Figure 2-26: Drainage causeway installed in Harrison RMA.

In Year 12, Altamont Sector staff began working on a project to improve the tread path within Harrison RMA. After rain events and during wet weather, Jammin Trail in Harrison RMA would experience ponding along the trail, resulting in trail widening due to OHVs avoiding the puddles that would collect along the trail. To counter this, Natural Resource staff proposed installing drain lenses along the drainage area of Jammin Trail to allow for drainage to flow without impacting the trail. This project will be completed and reopened to the public in Year 13.

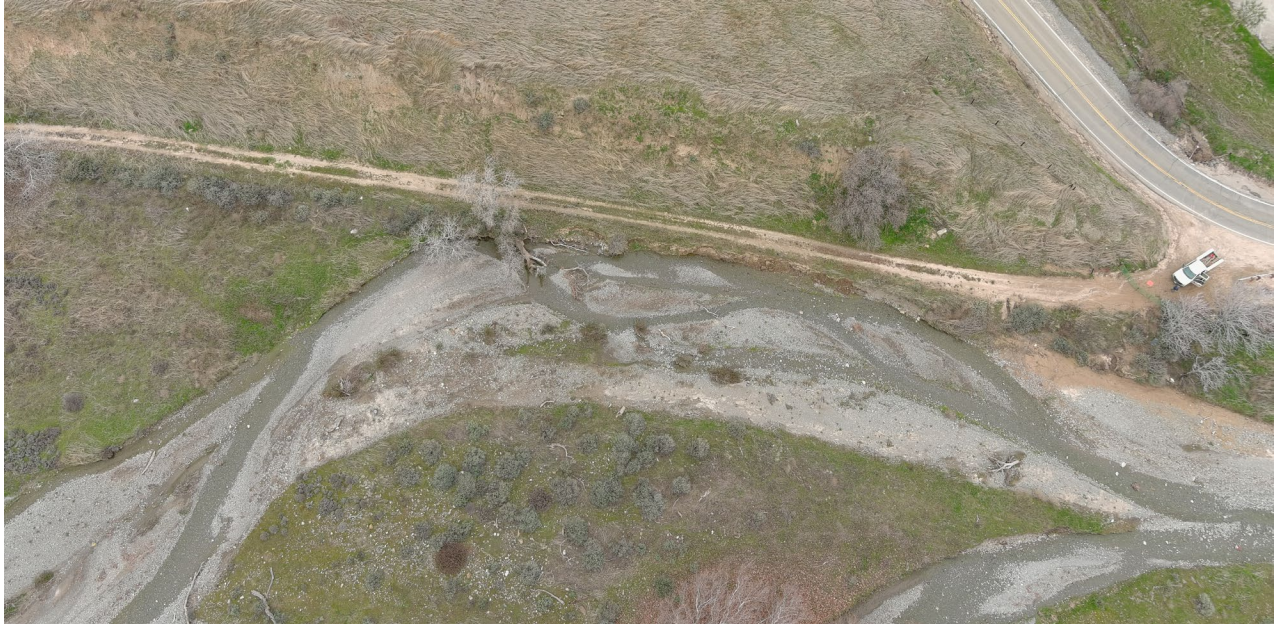
Figure 2-27: Drone photo of the emergency repair at the Tesla property.

During Year 11, flow in Corral Hollow Creek began to undermine the historic road that leads to the Tesla mine property in the Altamont Sector. Emergency repairs were required to prevent the creek from washing away access to this property and a significant portion of the footprint of the historic Alameda-San Joaquin railroad. In coordination with regulatory agencies, Altamont Sector staff worked to stabilize the road to prevent loss of a historic feature. Revegetation efforts were applied to the area to encourage the growth of native forbs. Altamont Sector staff are planning invasive vegetation removal activities at the Tesla property for Year 13 to limit the spread of invasives in the Corral Hollow watershed.
