DRAFT 2025 CARNEGIE STATE VEHICULAR RECREATION AREA SOIL CONSERVATION PLAN

November 2025

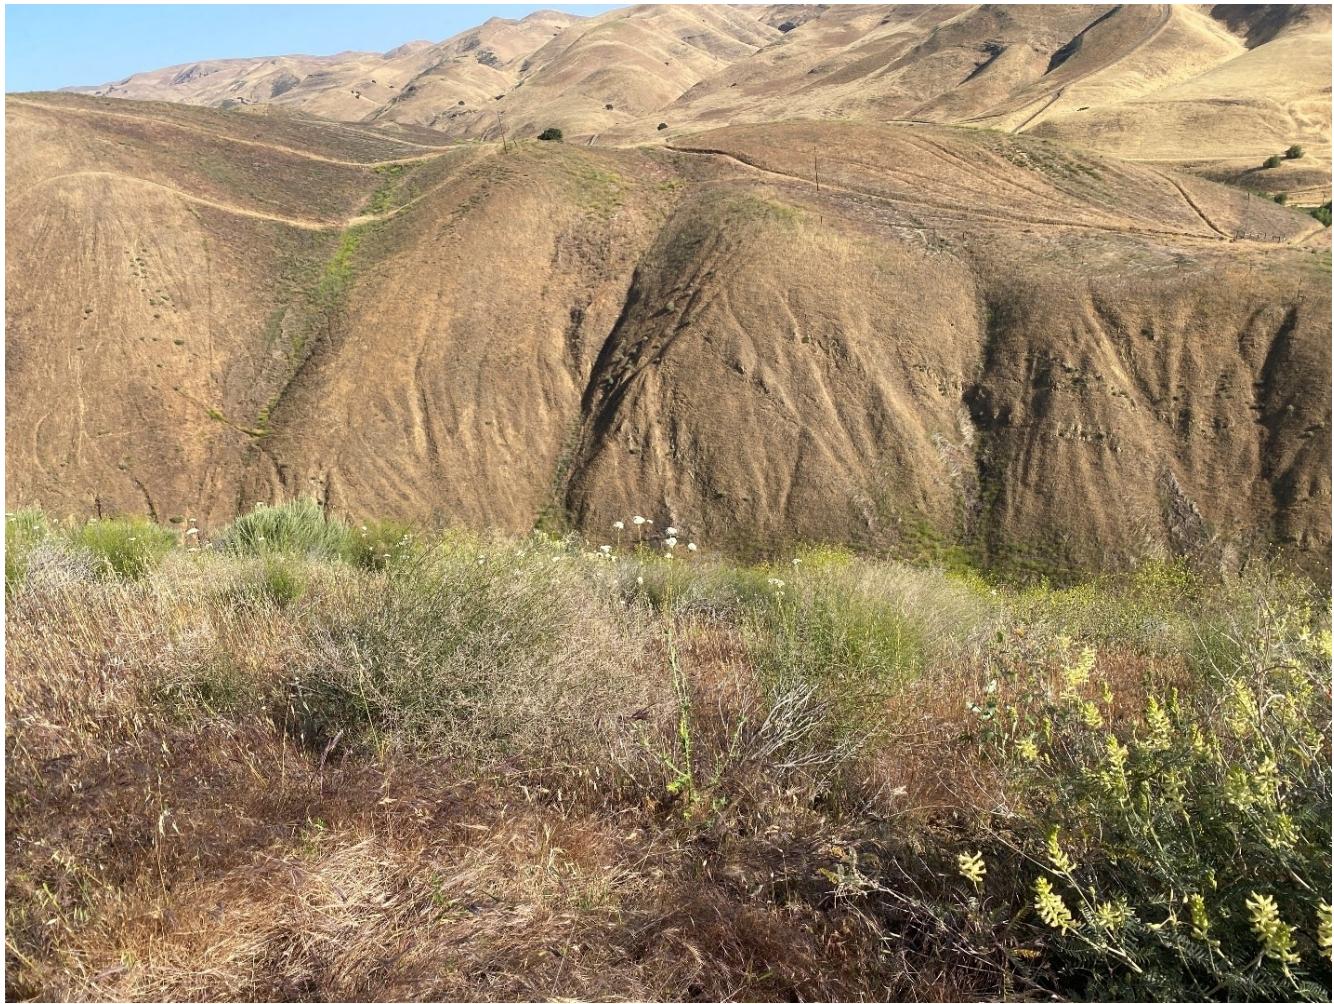
Figure 6. Photo of steep hills at Carnegie SVRA. This area is now operated as a trails-only riding area.

The remaining acreage of the park, known as the hills, is made up of hilly terrain with elevations up to almost 1,800 ft and slopes ranging from 15-70% (Figure 6). There are five entrances to the hills from the valley floor that are wide enough for vehicle use that serve as access roads and provide emergency and staff vehicle access through approximately 14 miles of trails in the hills. The access roads (Kiln, Los Osos, Juniper, Franciscan, and Pottery) are rated for beginner riders with a few segments of the trails rated for intermediate riders. Beyond the access roads, the trails are mainly intermediate to advanced rider skill level. An approximate breakdown of the skill level of OHV recreation at Carnegie SVRA is

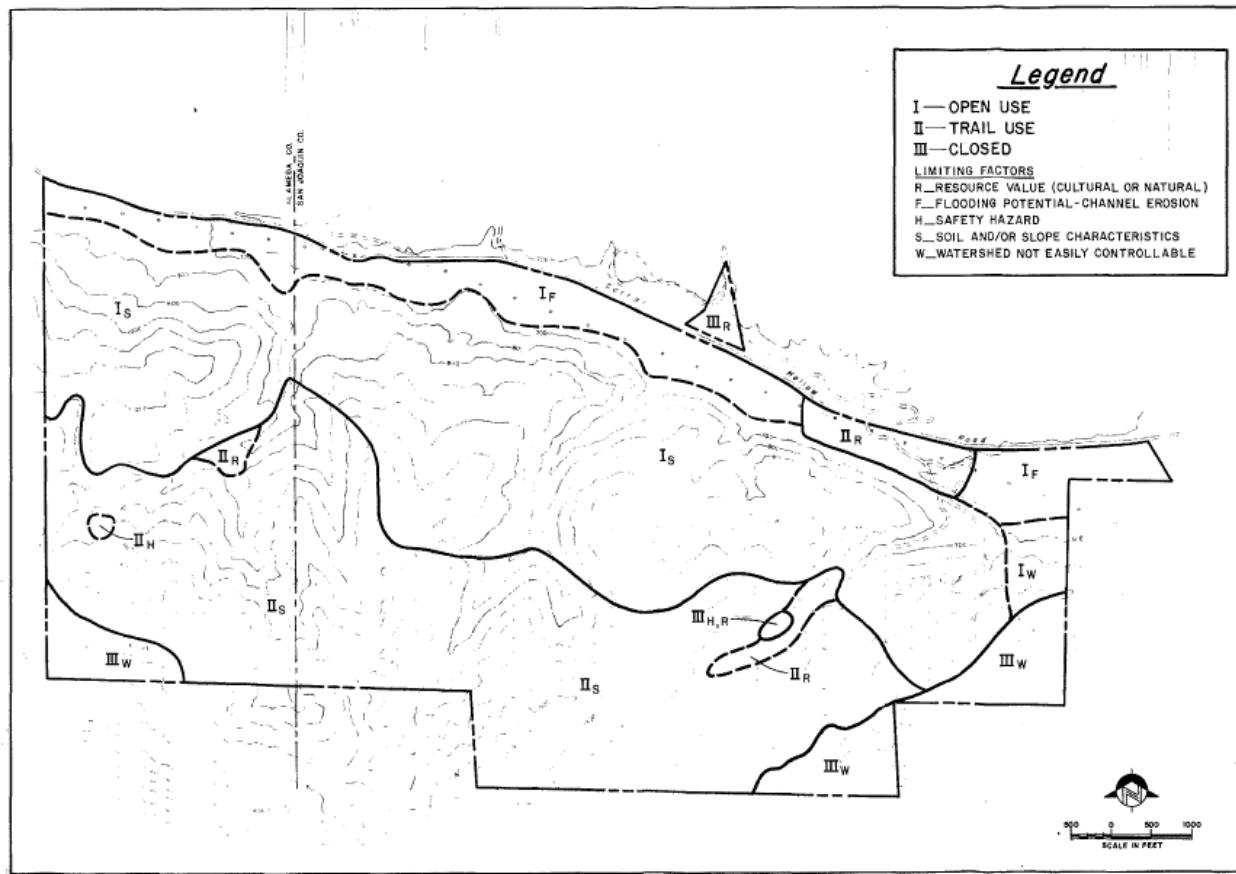
areas of the park needed to be more restrictive to OHV-use. This prompted management to create distinctions between “trails only” areas and areas where users would not be restricted to a trail system. The southern hills of the SVRA were designated as “trails only” riding due to the friable soils and sensitive habitat types present; the northern hills were designated as “open-riding”, where OHV use were free to recreate (Figure 9). A sound resource management program would be required to address the problems that would only worsen if left untreated. An Erosion Control Plan was developed for the newly acquired Carnegie SVRA and was adopted in 1985.

Figure 9. Level of use map from the 1981 Carnegie SVRA General Plan. Northern hills are available for open riding and southern hills are limited to trails only riding; various closure areas are indicated.

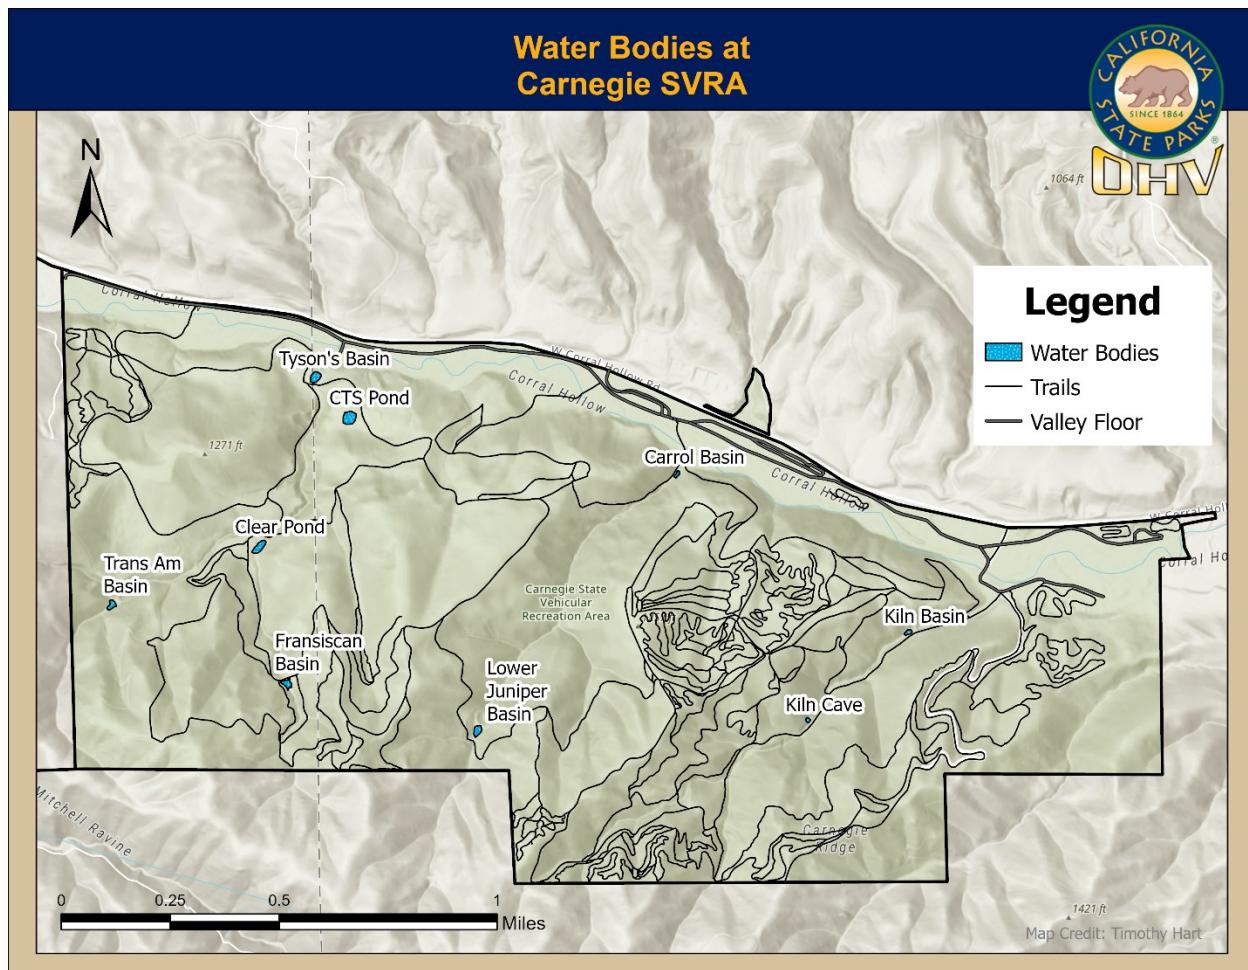
Figure 10. Map of water features within Carnegie SVRA.

Corral Hollow Creek is susceptible to strong flows after heavy rains, which may cause flooding during significant storm events. A 2009 update to the FEMA Flood Insurance Rate maps of the 100-year floodplain for Corral Hollow Creek covered the San Joaquin County portion of the SVRA, only accounting for a small portion of the SVRA that falls within the 100-year floodplain for the creek. The remainder of the SVRA is above the 500-year floodplain level (DPR, 2024). The strong flows that are channeled through the valley floor of the SVRA have a long history of damaging infrastructure in the canyon, including the flood of 1911 that played a part in the demise of the Carnegie Brick and Pottery Company.

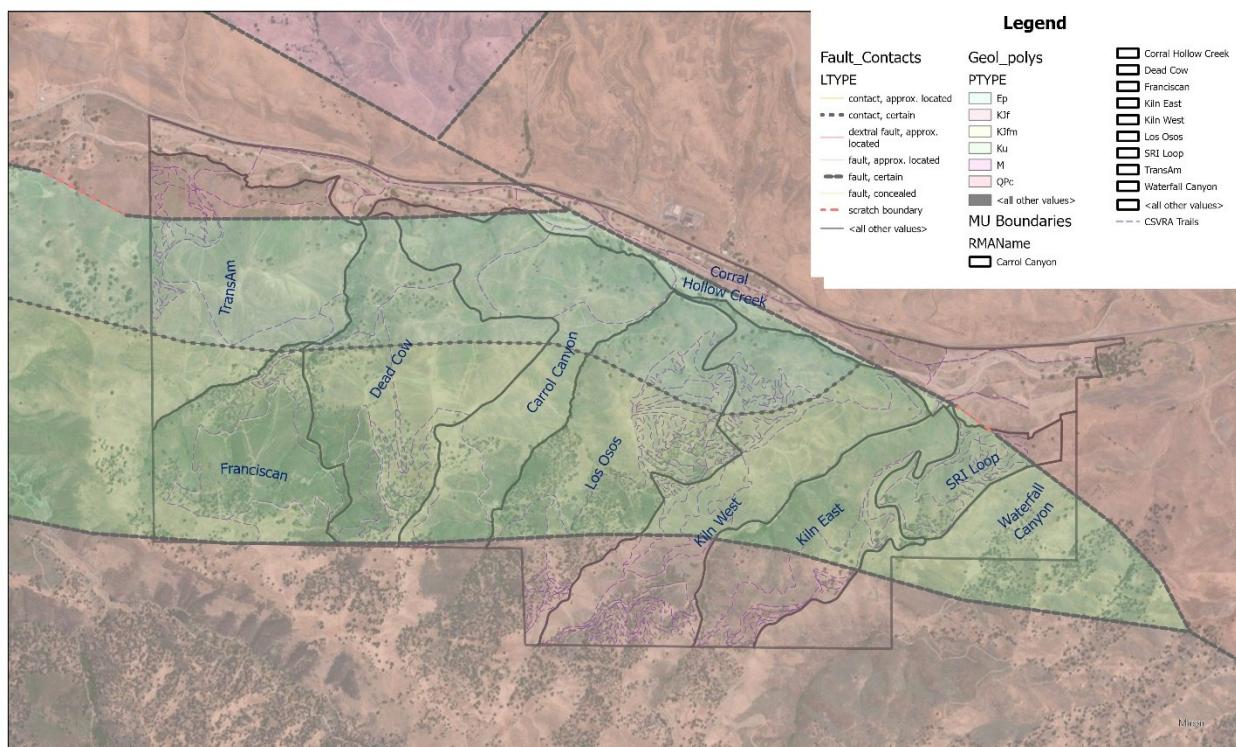
Figure 12. Local geology map for Carnegie SVRA.

metasedimentary rocks from the Upper Cretaceous (Ep) overlain by marine sedimentary rocks from the Paleocene (Ku), illustrated in Figure 12. The oldest rock assemblage present in CSVRA is Cretaceous-Jurassic age Franciscan Complex (KJf), composing the southernmost portion of the park beneath the Paleocene marine sedimentary rocks. The northern portion of the park is composed of Pliocene to Pleistocene age continental sedimentary deposits (QPc), mostly loosely consolidated, that lie unconformably over Ep. Outside of Carnegie SVRA to the north, Miocene age marine sedimentary rocks lie unconformably over the younger QPc deposits. Approximately 4,000 meters south of CSVRA, Franciscan Complex blocks form a chaotic mélange in a matrix composed of fragmented and sheared sedimentary and metamorphic rock, likely influenced by activity on the Tesla fault, which truncates older fault surfaces of the Coast Range thrust-fault system (Raymond, 2019). Local and regional geology and tectonics is discussed in more detail in Appendix 2.4.5 – Geologic and Seismic Assessment.

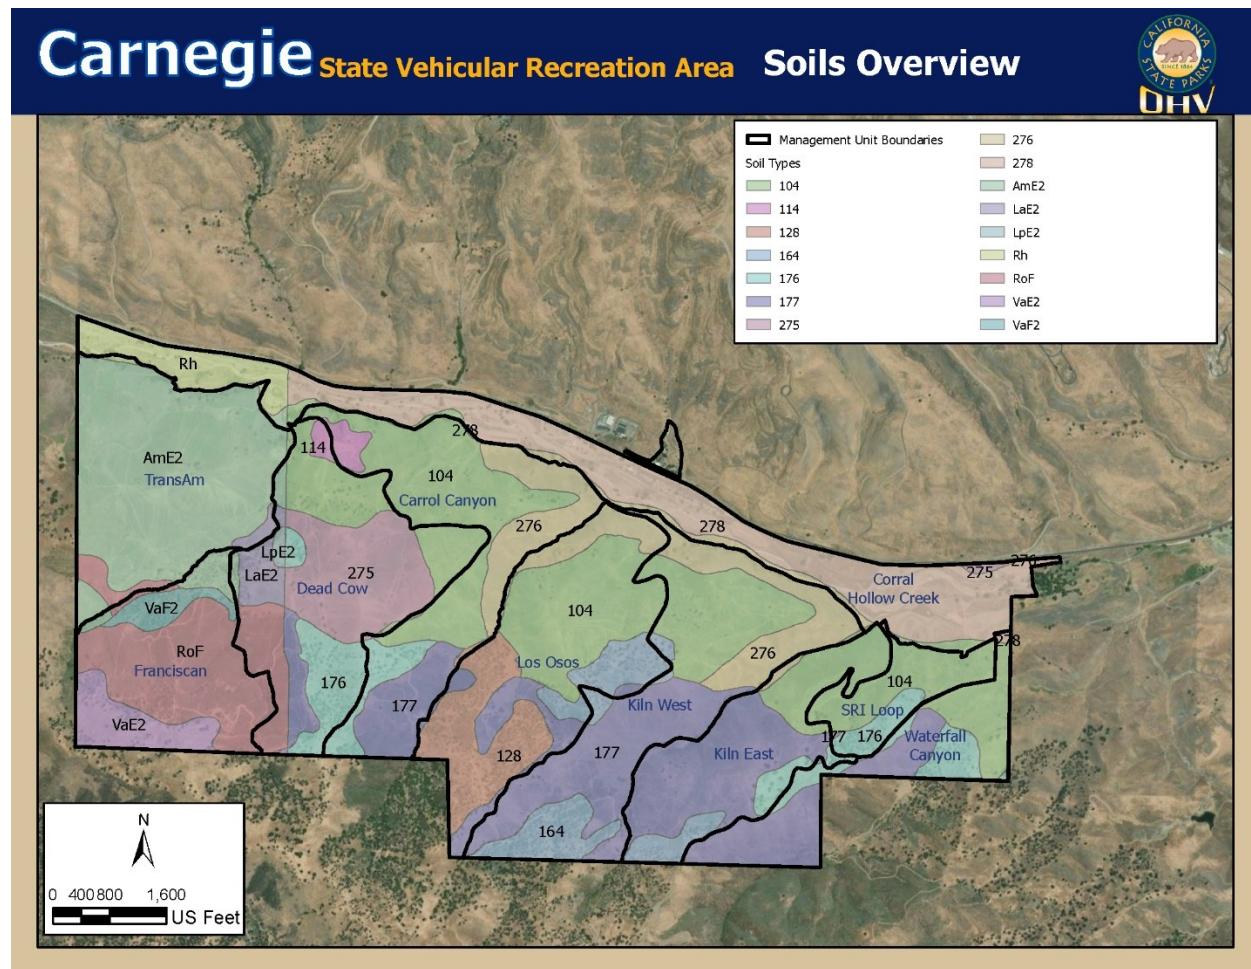
Figure 13. Soils map for Carnegie SVRA.

Seventeen different soil types are found within Carnegie SVRA; descriptions of each from the Soil Survey Geographic (SSURGO) database (USDA, 2024) can be found in Figure 13 of Appendix 2.4.6. Soil Types and Properties Table, corresponding to Figure 13. On the western end of the SVRA, soils are classified using the Alameda County SSURGO database descriptions up until the San Joaquin County line. From the Alameda County line to the eastern boundary of the SVRA, soils are classified using the San Joaquin County SSURGO database. The soil properties differ considerably between the two counties in the SSURGO database. The mapped soil units on Figure 13 represent areas within Carnegie SVRA

dominated by one or more major kinds of soil, which may be a phase of a soil series, or a complex composed of two or more soil types combined in an intricate pattern or small scale that they cannot be shown separately on the map.

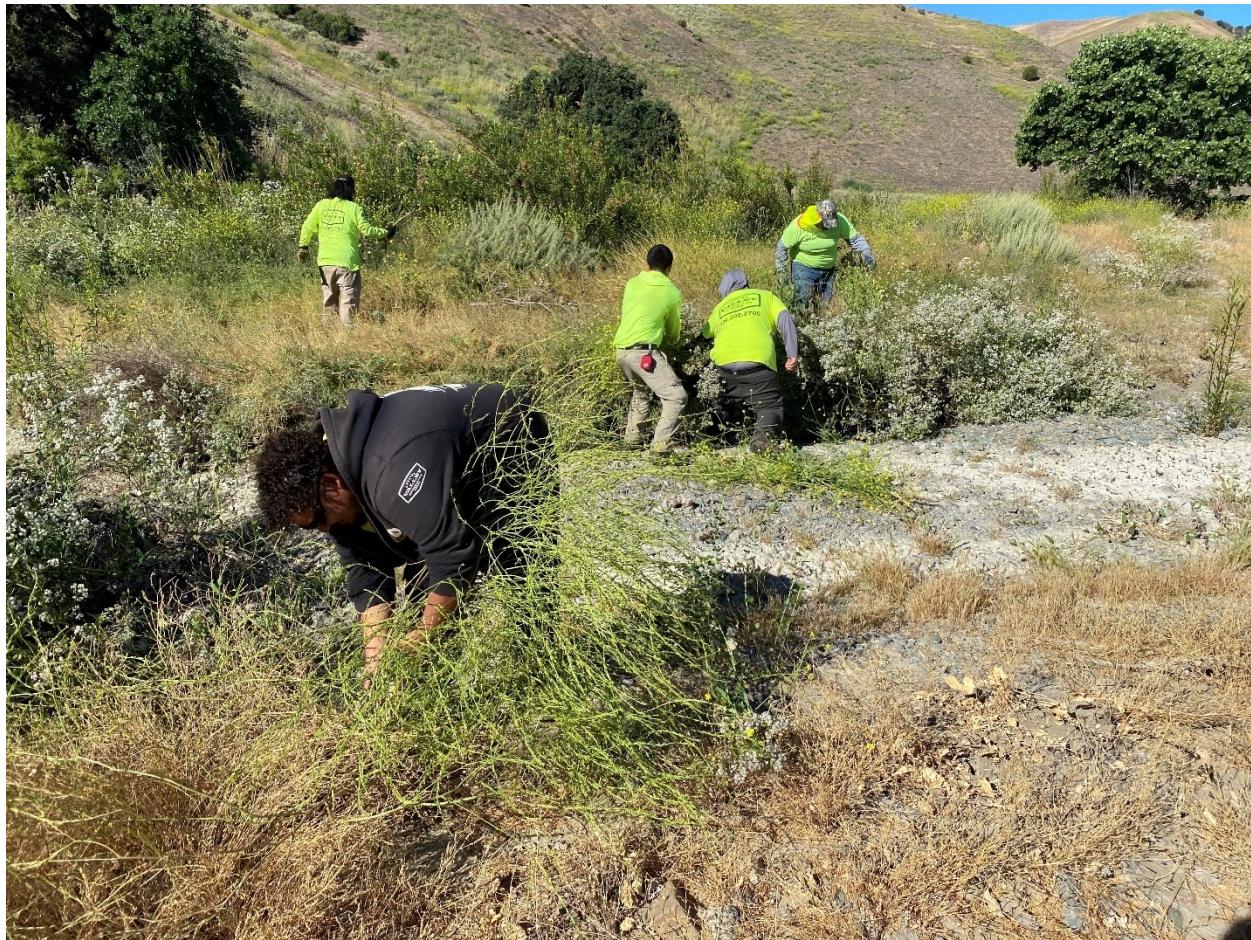
Figure 17. Greater Valley Conservation Corp members removing invasive plants in the riparian corridor of Corral Hollow Creek MU

and reduce the impact invasive plants can have on native plants by reducing available resources present, as demonstrated in Figure 17. This effort is an on-going restoration project within the SVRA.

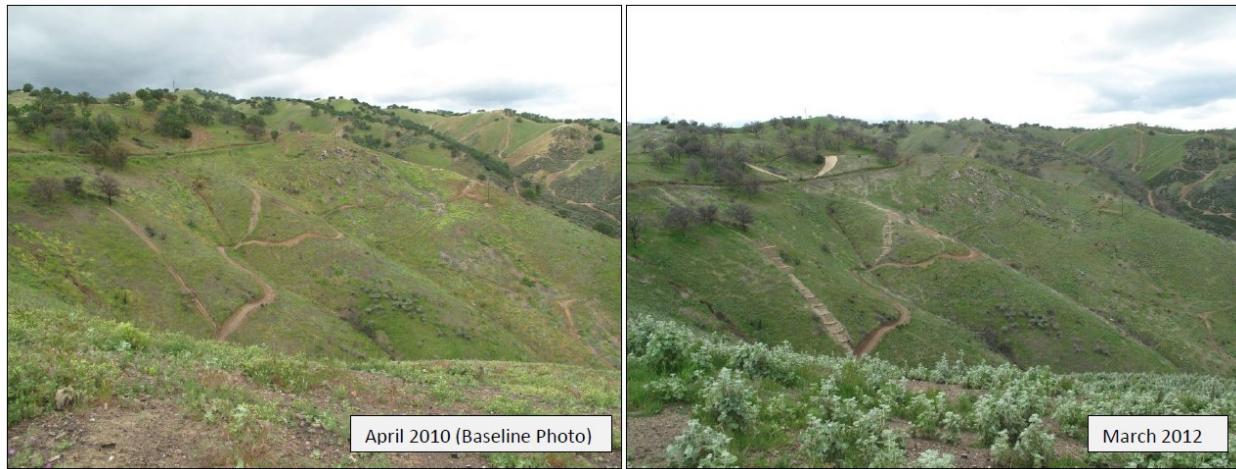
Figure 18. Photo of Kiln East MU rehabilitation project from 2010 to 2012. BMPs have been installed to rehabilitate unauthorized trails in the photo on the right.

This 119.3-acre MU is operated entirely as a “trails-only” managed riding area, composed of two RMA units: Kiln East RMA and Raven RMA. The trail system in this area was installed in 1995 with the intent of reducing volunteer trails, but lacked a successful strategy to limit the issue of riders creating new trails. In August 2009, a fire started outside of the unit and burned the majority of the Kiln East MU, giving Parks staff the opportunity to implement a large-scale rehabilitation project based on both active and passive techniques. Kiln East RMA was rehabilitated and reopened in October 2011 as the second RMA to adopt the new model of “trails-only” riding (Figure 18). The trail system within Kiln East RMA was designed to complement the trail system within the MU to the north of Kiln East, SRI Loop MU, which predates Kiln East. Kiln East RMA is one of the larger RMAs in the SVRA, 112.4 acres in size, providing approximately 2.98 miles of trails within the RMA. This RMA does not typically experience regular instances of off-trail riding despite the lack of fencing to prevent it, possibly due to the varying topography and complex trail system within the Kiln East RMA.

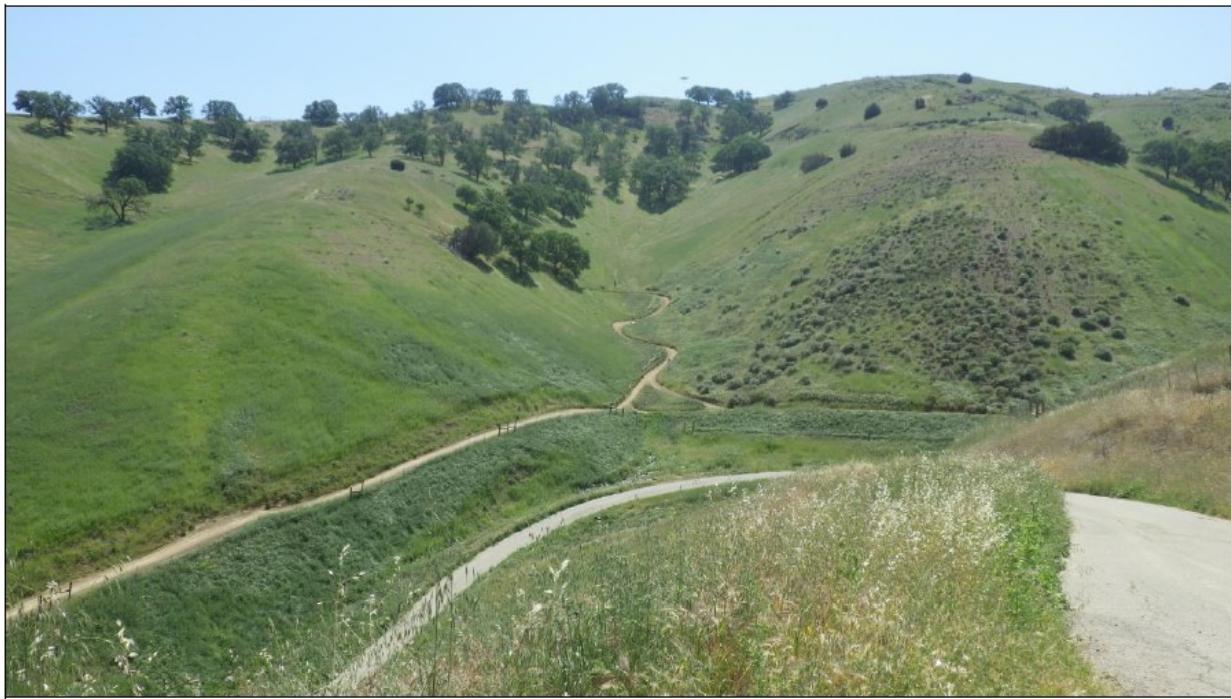
SRI Loop RMA was closed for rehabilitation in August 2009 and reopened in January 2011 as the first RMA under the new model, which relied on minimal fencing, frequent monitoring and swift management actions to enforce the “Trails Only” message (Figure 18). In the first two years of implementation of the RMA program, this RMA was closed approximately eight times due to off-trail riding activity and two citations were issued. Vegetation in this area is predominantly California annual and perennial grassland, which grew back quickly post-rehabilitation and provided better natural filtration for sediment that may mobilize in stormwater and increase potential for erosion or soil loss. Blue oaks, junipers, and black sage make up the secondary vegetation types in this RMA. SRI Loop RMA offers 1.08 miles of secondary trails.

Figure 21. Photo of SRI Loop RMA, the first RMA implemented at the SVRA in 2011. Photo taken in April 2018.

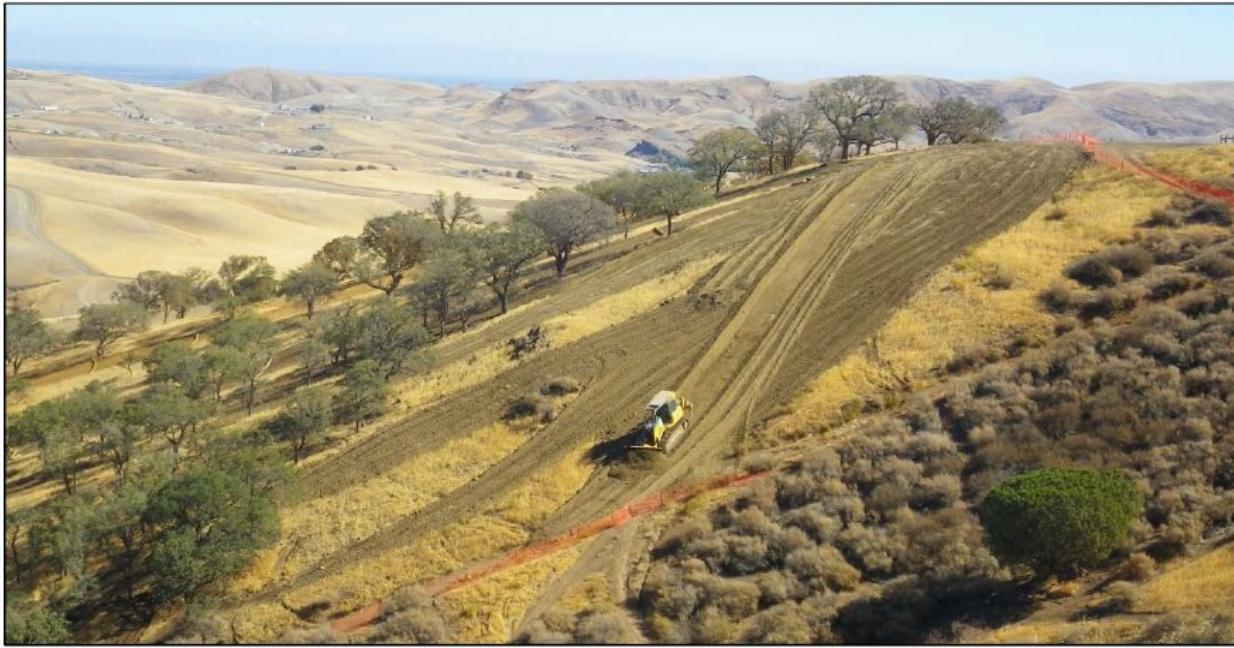
Figure 24. Photo of Seven Trails rehabilitation project, which reopened as an RMA in 2015.

Seven Trails RMA is approximately 27 acres in size and was rehabilitated in Fall of 2014 (Figure 24). It reopened in Spring 2015 after fencing was installed around the perimeter of

the RMA and trail layout was designed with assistance from the CAT. This RMA is predominantly composed of Gonzaga-Honker-Franciscan complex soils, 30-50% slopes, with some deposits of Honker-Vallecitos-Honkey-Eroded complex soil, 30-50% slopes. Honker soils are typically part loam with gravelly clay and are classified as well drained soils with a moderately high saturated hydraulic conductivity, implying that these soils can transmit water flow under saturated soil conditions. Honker soils are well drained with a high shrink-swell potential and are low susceptibility to wind erosion.

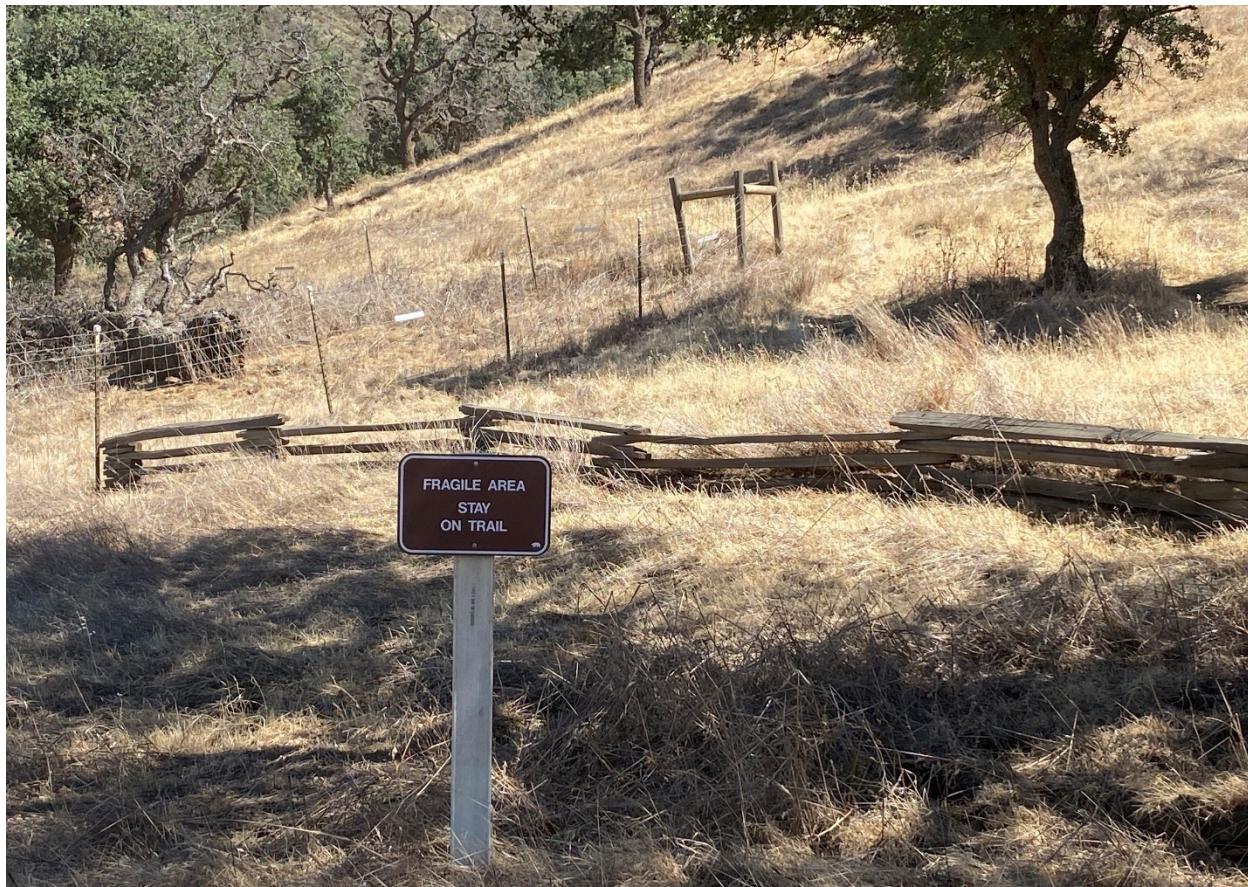
Throughout the SVRA, various areas permanently restrict OHV-activity to protect resources. Culturally significant and environmentally sensitive sites are protected using fencing and gates (Figure 30). For example, over 70 acres of the floodplain of Corral Hollow Creek are fenced off to OHV-activity, limiting park visitors to a set of five designated creek

Figure 30. Photo showing resource closure area in Franciscan MU. Resources are protected using fencing, signage, education and enforcement.

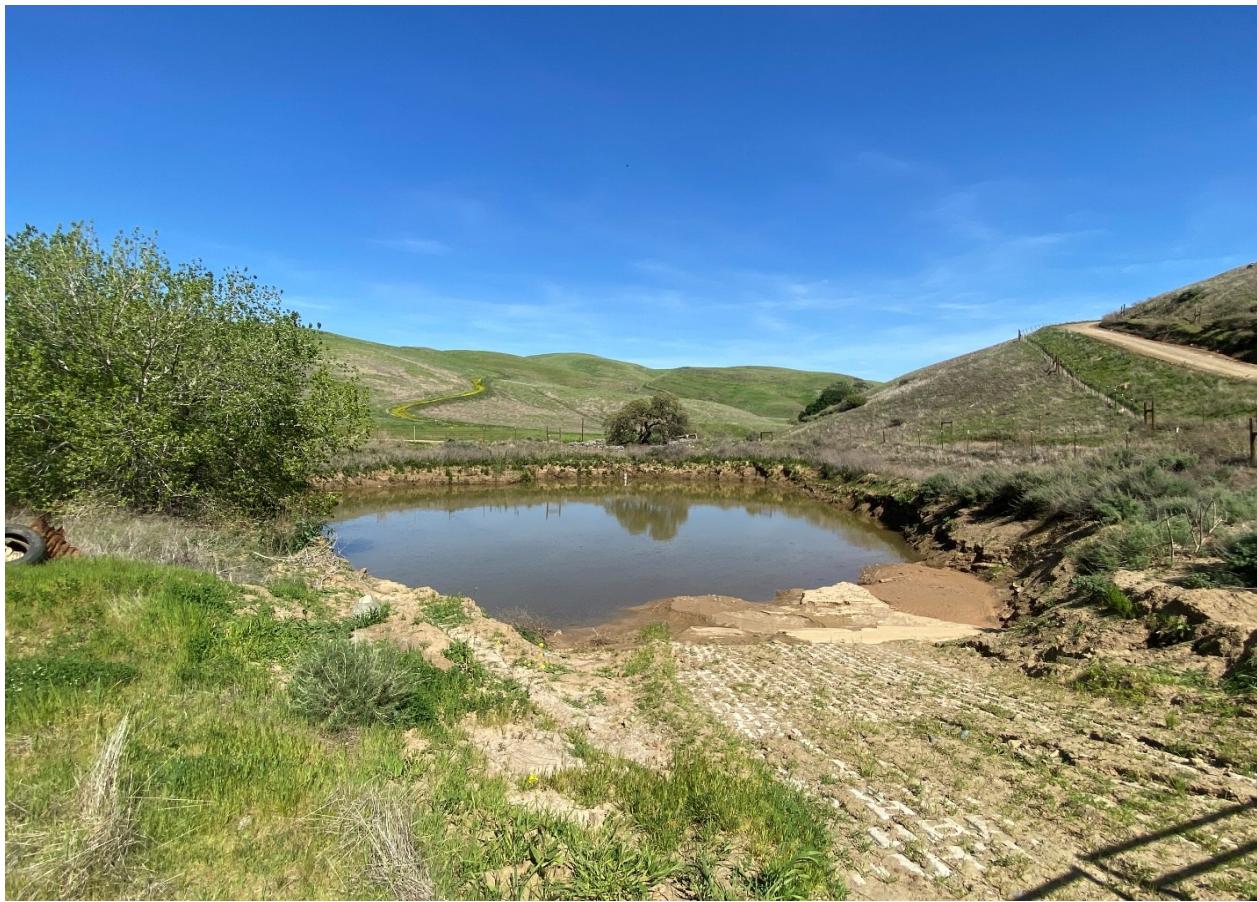
Figure 31. Photo of Tyson's Pond sediment basin.

Sediment basins are a part of the critical stormwater infrastructure, and an integral sediment control feature implemented at CSVRA. There are eight waterbodies within the CSVRA, five of which operate as sediment basins (Figure 32). Sediment basins are designed to slow and retain sediment-laden water long enough for deposition of coarse material and settlement of fine particles before being discharged into connecting tributaries. In general, a sediment basin consists of an inlet (either natural or piped with a culvert), a retention area, an earthen berm or gabion basket structure to impound water, and an outlet pipe. Most outlet structures have been reinforced with rock to prevent scour. Sediment basins provide good control of coarse sediment and can effectively trap medium-size sediment particles; however, suspended clay and fine silt particles in runoff require longer settling times in the basin without the additional of chemical flocculants to bind to and remove these finer-textured sediments.

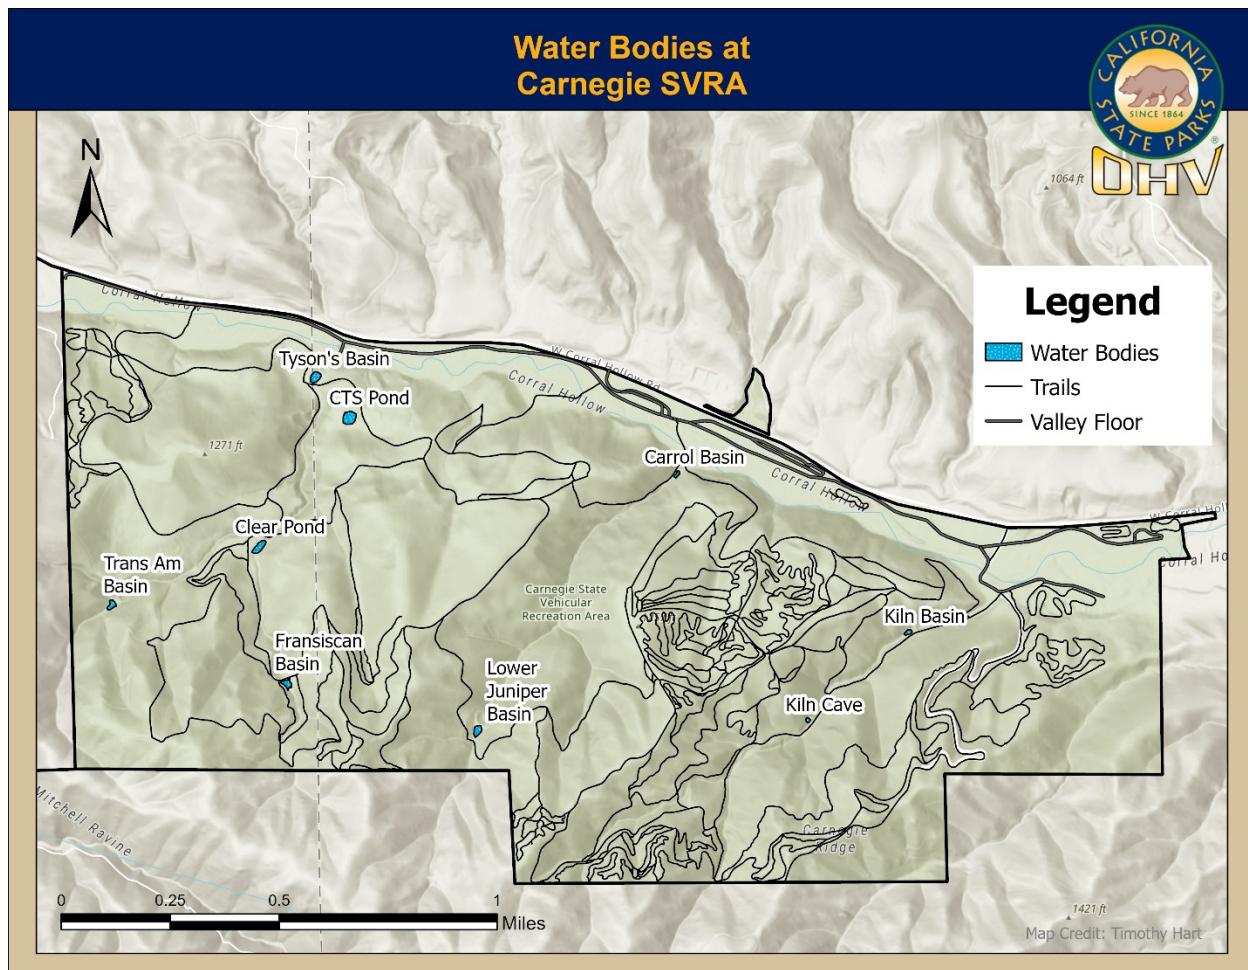
Figure 32. Figure showing locations of the sediment basins and ponds throughout CSVRA.

Figure 32 shows a map of the sediment ponds within the SVRA. Of these, Tyson's Pond, Carroll Pond, and Kiln Pond are considered the main three sediment basins and receive maintenance more regularly due to the location of the basins in the sub-watershed and the proximity to receiving waters. Franciscan Pond and Juniper Pond are sediment ponds that reside higher up in the sub-watersheds but still provide important stormwater runoff control that can affect the sediment load entering the basins lower in the watershed. Proper maintenance and regular monitoring of these upper sediment ponds at the start and at the end of the wet season should be conducted to ensure that wet storage capacity has not been exceeded.

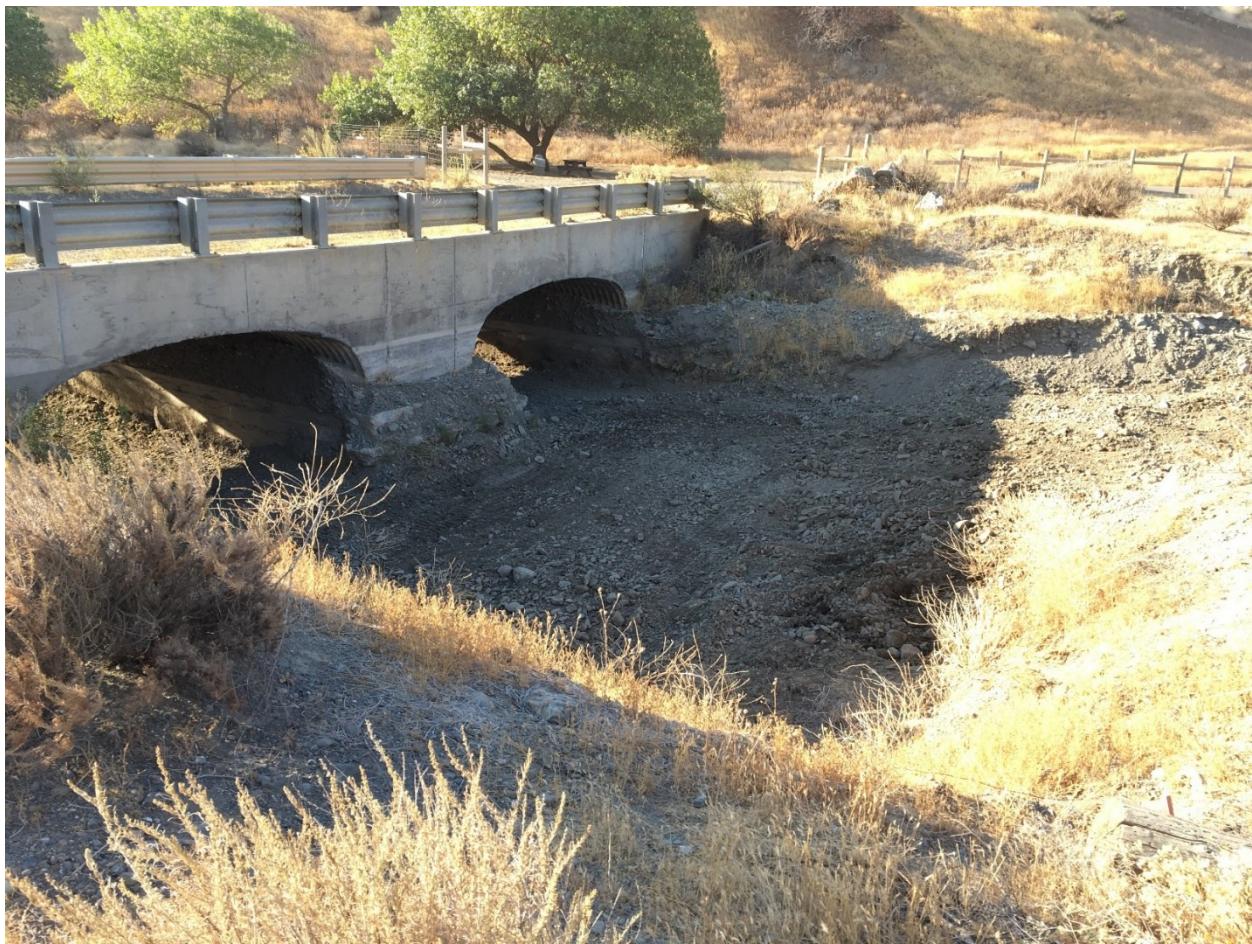
Figure 33. Photo of maintenance bridge crossing and culverts shortly after annual maintenance.

The crossing at the maintenance bridge is composed of two six-foot culverts underneath a concrete bridge structure (Figure 33). This crossing and the sediment that accumulates underneath it receive annual or as-needed maintenance to allow flow from the creek to pass through the culverts without impingement. A skid-steer is used in combination with an excavator to remove sediment from these culverts. Maintenance of this crossing is subject to regulatory permitting along with the maintenance of the sediment basins.

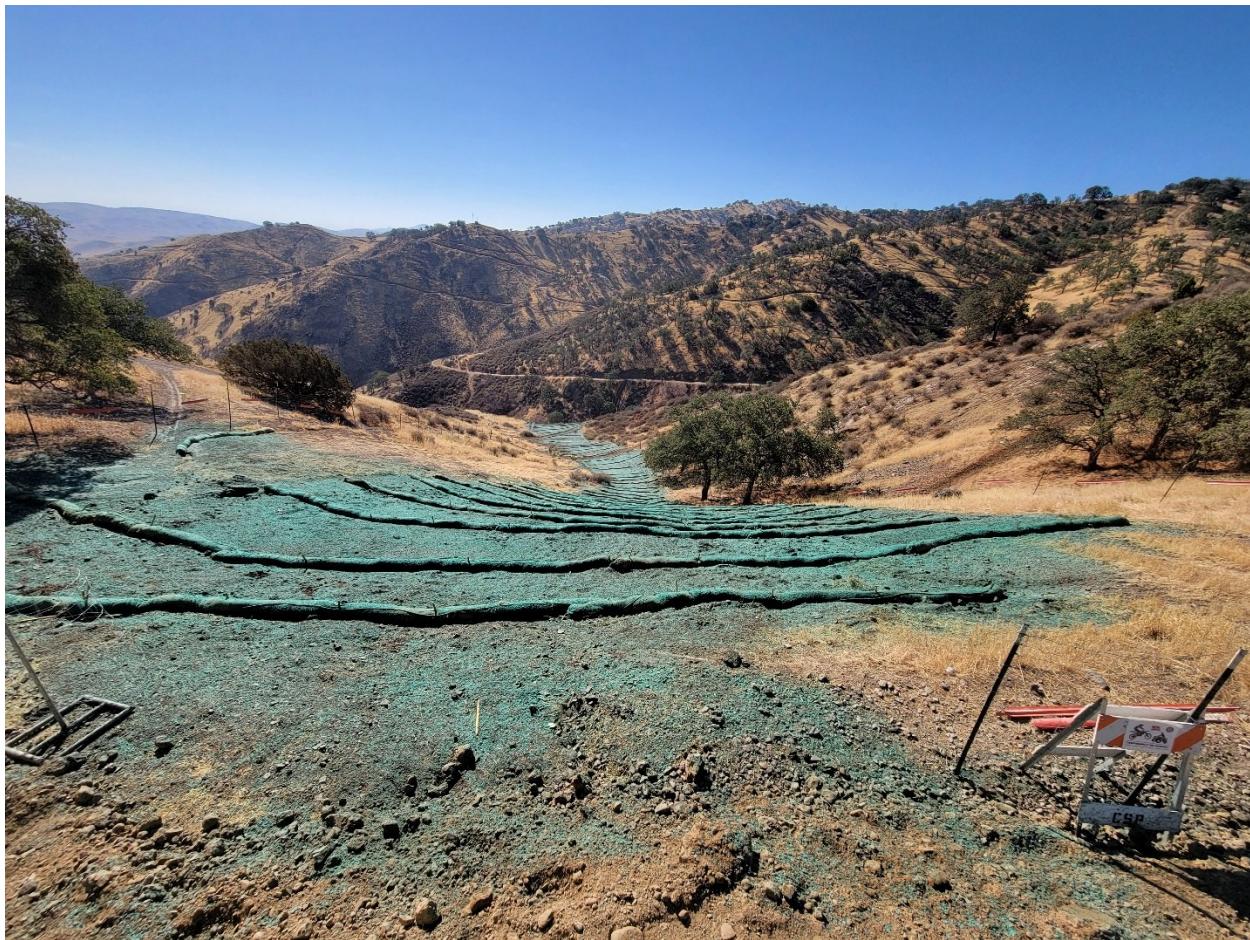
Figure 34. Photo of rehabilitation efforts on Kiln West MU after earthwork is conducted.

Hydromulching is a soil stabilization method where fiber mulch is applied to exposed or disturbed areas of soil to prevent raindrop impact erosion. The fiber is hydraulically applied in a slurry, produced by mixing fiber, water and a binding agent together in a mechanical hydroseeder. Effectiveness of hydromulching is dependent on the application rate, which may vary. Hydromulching is also used as a tackifier to anchor straw mulch and apply seed. Hydromulch is sometimes the only acceptable treatment for soil stabilization on steep or rocky slopes that cannot be treated by other means. Effectiveness of hydromulching on this type of terrain may be supplemented using erosion control blankets or hydraulic planting techniques. The conditions present at CSVRA often require hydromulch application for temporary and permanent erosion control (Figure 34).

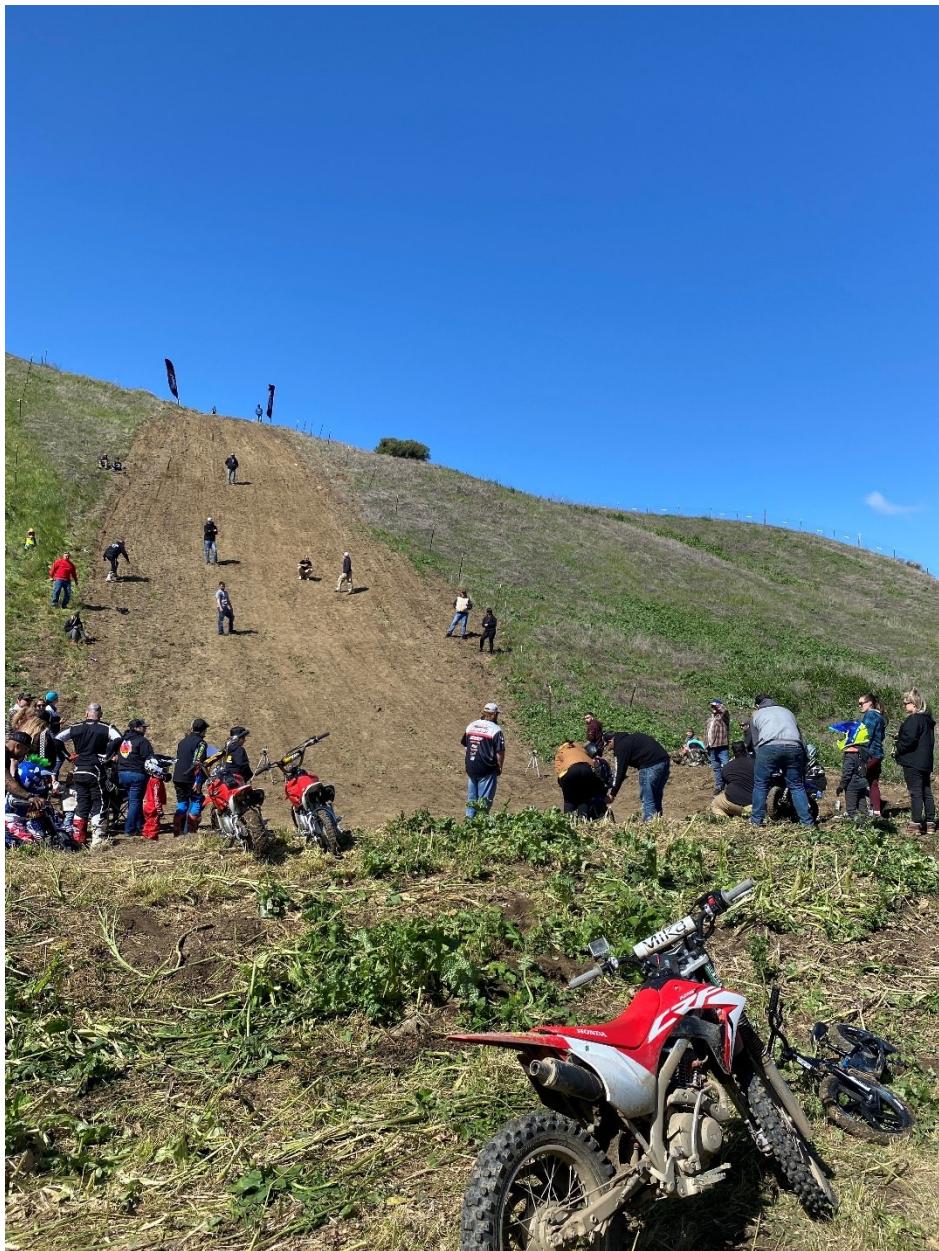
Figure 35. Photo of the kids' hill within the hillclimb event area during an event. These large swaths of exposed soil are targeted for rehabilitation efforts after the last event of each season.

Hillclimb events occur several weekends per year at Carnegie SVRA and draw thousands of visitors to the SVRA to observe the races (Figure 35). Prior to each event, the event coordinator completes a Special Event Permit to host the hillclimbs. The Special Event Permit includes conditions for resource protection and restoration measures, which are employed by event staff and overseen by Carnegie's supervising State Parks peace officer (SPPO) and the environmental scientist. One condition of the event permit involves getting SPPO and environmental scientist approval over race routes to prevent hydrologic connections that could channel stormwater and minimize the footprint of disturbance for the event. Another condition of the event permit includes repairing race routes via the use of spreading seed, hydroseeding, or spreading straw. Depending on the condition of the hillside, the environmental scientist may suggest that event staff use hand tools to knock down edges of race lines and encourage the spread of the seed bank in existing soil. Racetracks are to be covered within four weeks of the final special event for the season. This maintenance is overseen by natural resources staff with input from the environmental scientist. The event coordinator works closely with the environmental scientist, supervising State Parks peace officer, and natural resources staff to ensure that the special event facility is operated sustainably so that this recreational opportunity will be available to future generations. The special event area is evaluated annually as a condition of Carnegie's MS4 permit; more details about these inspections can be found in the Altamont Sector SWMP Annual Reports (https://ohv.parks.ca.gov/?page_id=31610).

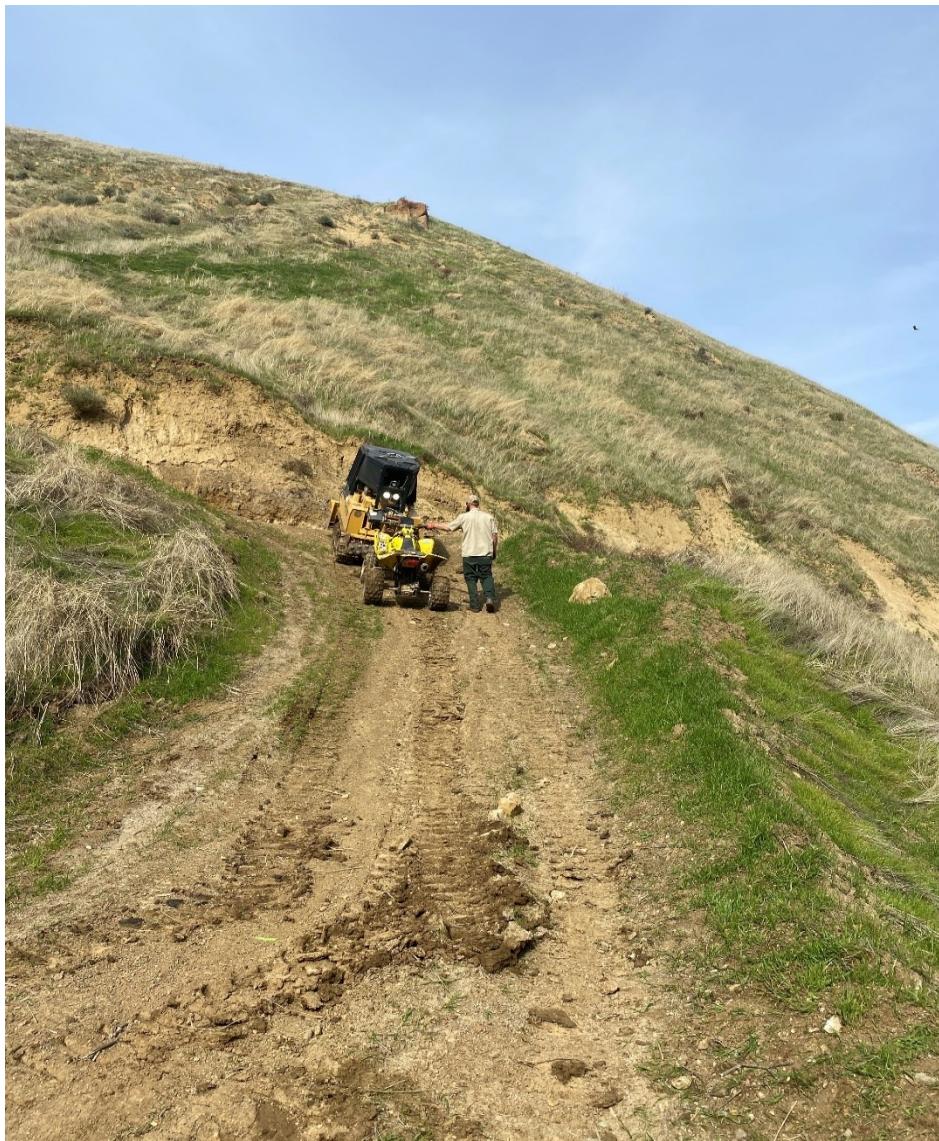
Figure 37. Photo of a trail dozer being used to remove an ATV that got stuck in a ravine in Carroll Canyon.

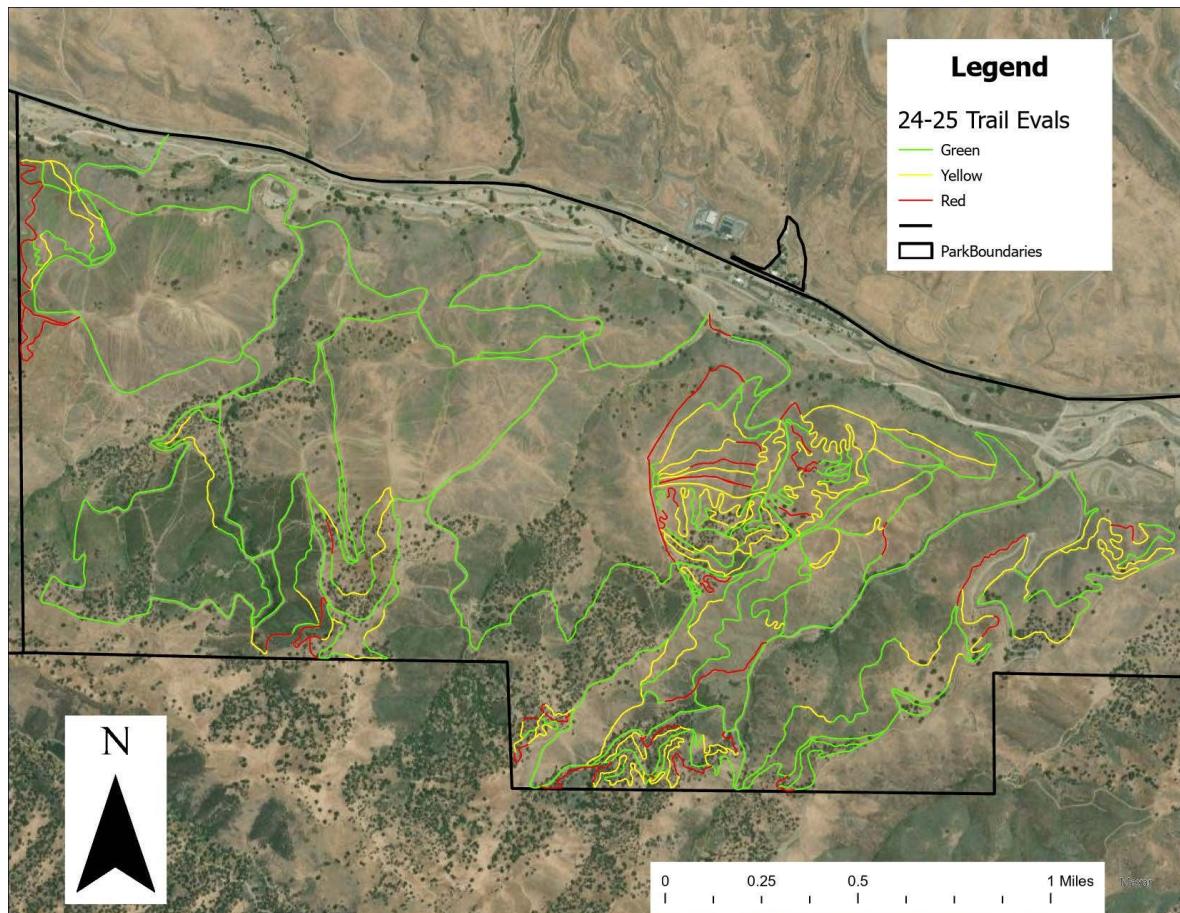
Figure 38. Carnegie trail assessment rating map from 2024-2025.

Trail condition is an important metric for evaluating sediment management because poor trail condition could be a source of erosion in the SVRA. The overall goal is to have a rigorous system to evaluate and inform maintenance priorities. Ideally, green trail ratings would be high and yellow and red ratings low or non-existent. While the trail ratings are not solely a representation of soil loss because there are other factors that are measured simultaneously, they provide a useful general overview of trail conditions that can be used to measure progress over time. Figure 38 depicts the results from the trail conditions evaluation for the 2024-2025 season.
