DRAFT 2025 CARNEGIE STATE VEHICULAR RECREATION AREA SOIL CONSERVATION PLAN

November 2025

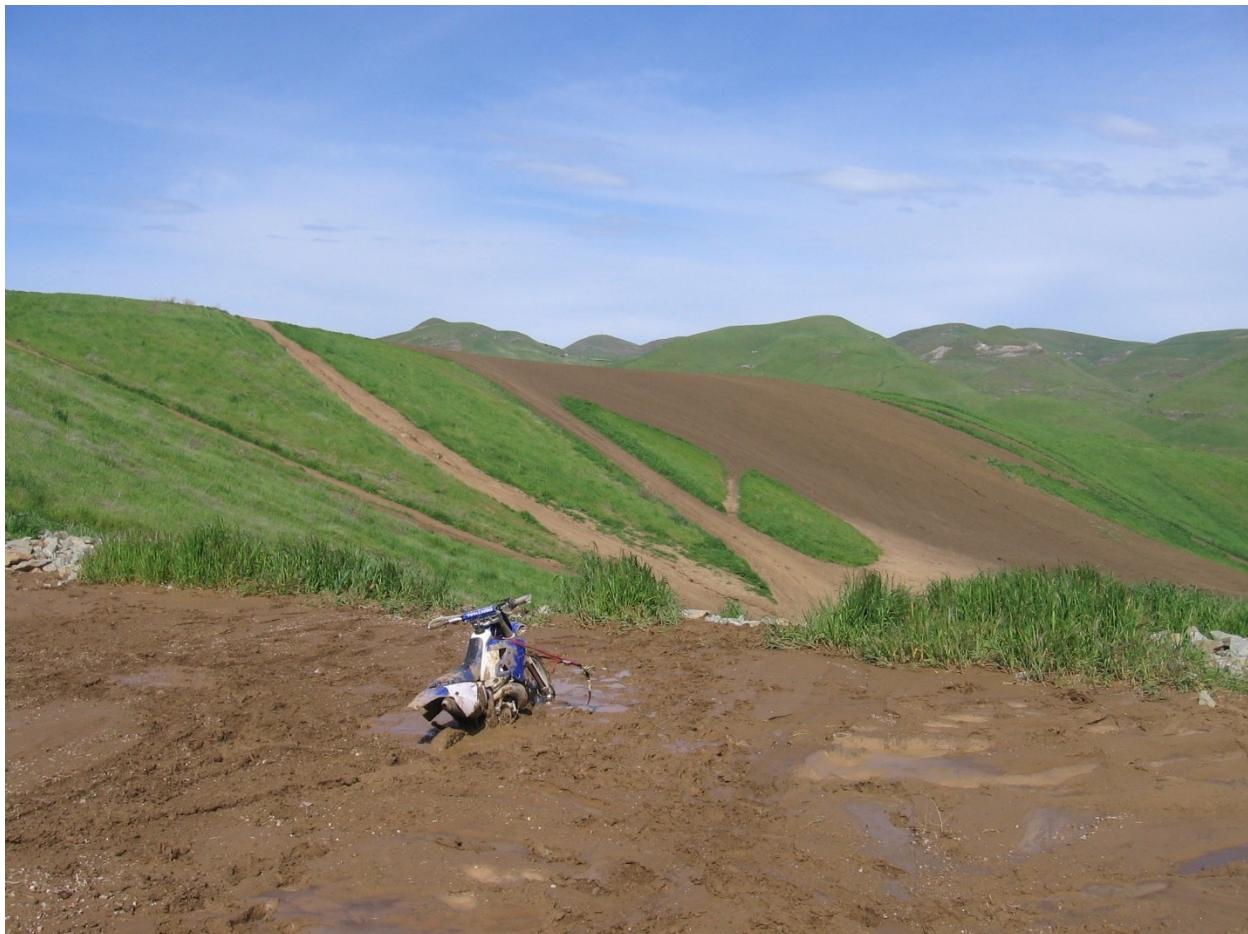
Figure 39. Photo showing muddy conditions at Carnegie SVRA. The high shrink-swell potential of the clay soil present can compromise emergency response after a storm.

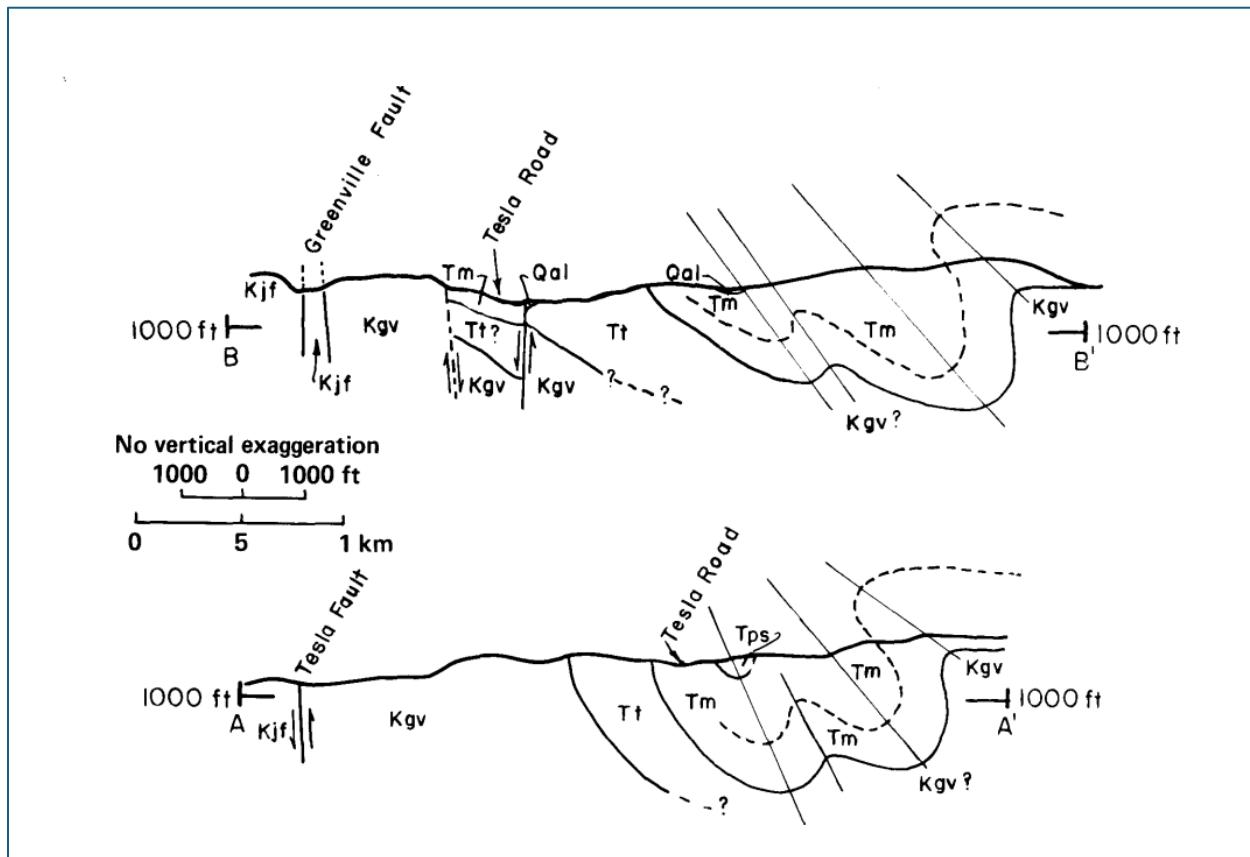
Figure 41. Fault Map for Regional Faults to Carnegie SVRA (Carpenter et al.)

Carnegie, and Patterson Pass Faults. The following brief descriptions of these faults are based on investigations either conducted by or summarized in Carpenter et al.:
