EASTERN KERN COUNTY ONYX RANCH SVRA SOIL CONSERVATION PLAN

1 Introduction

1.1 Purpose

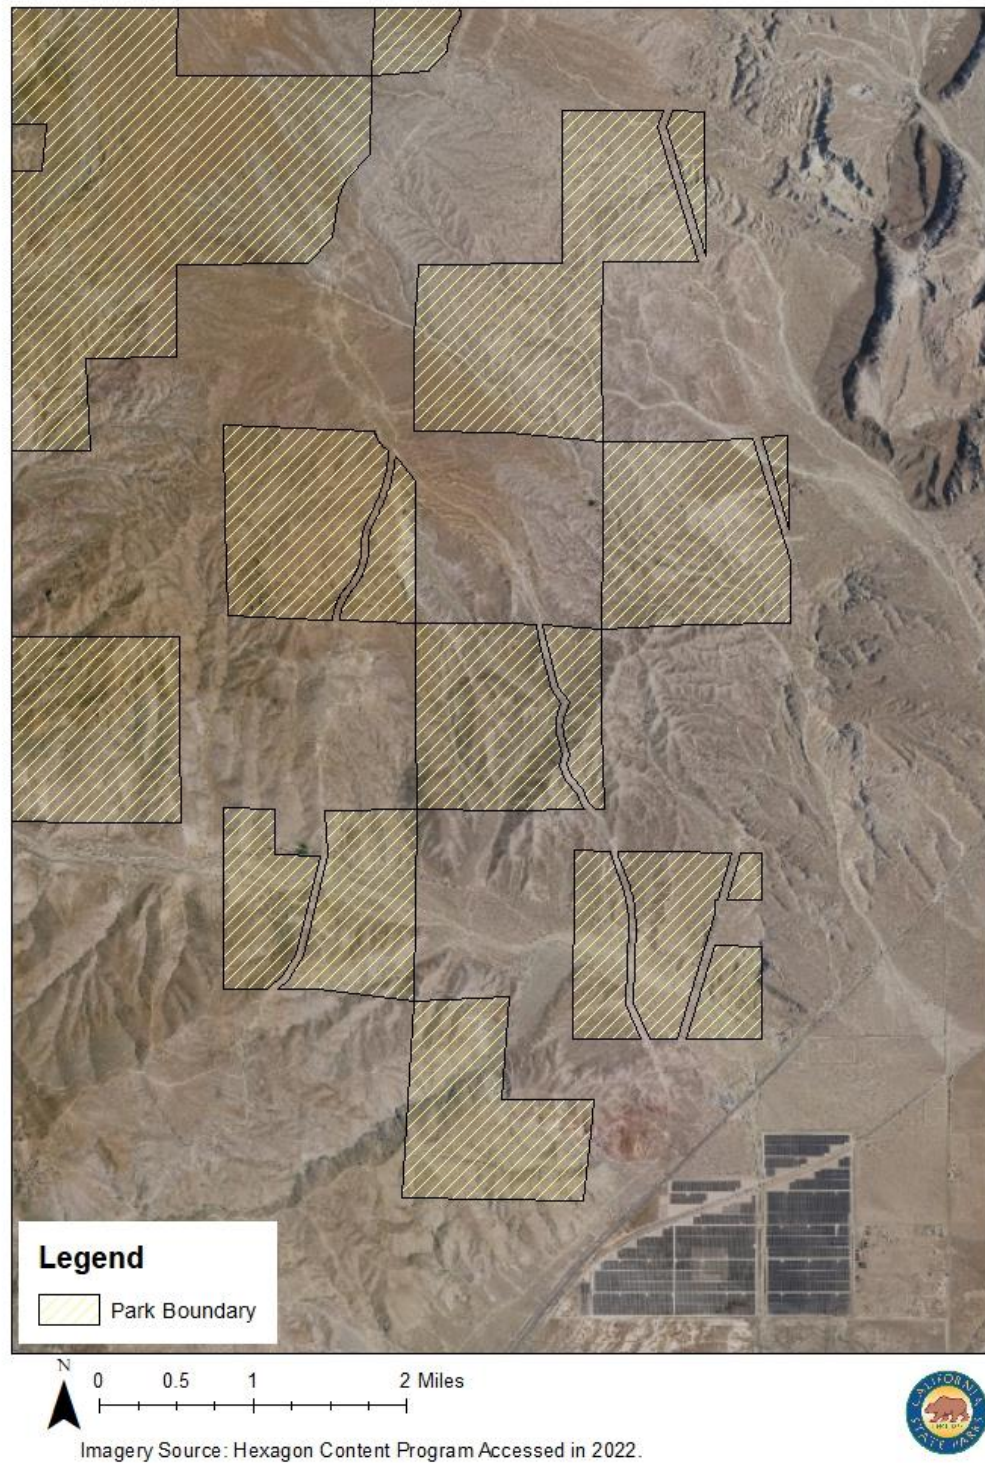
Eastern Kern Onyx Ranch SVRA Parcels Near LADWP Parcels

Figure 2. Aerial map showing CDPR parcels adjacent to LADWP parcels. The linear gaps within the park boundary show where LADWP owns property (parcels) for the ROWs of pipelines and powerlines.

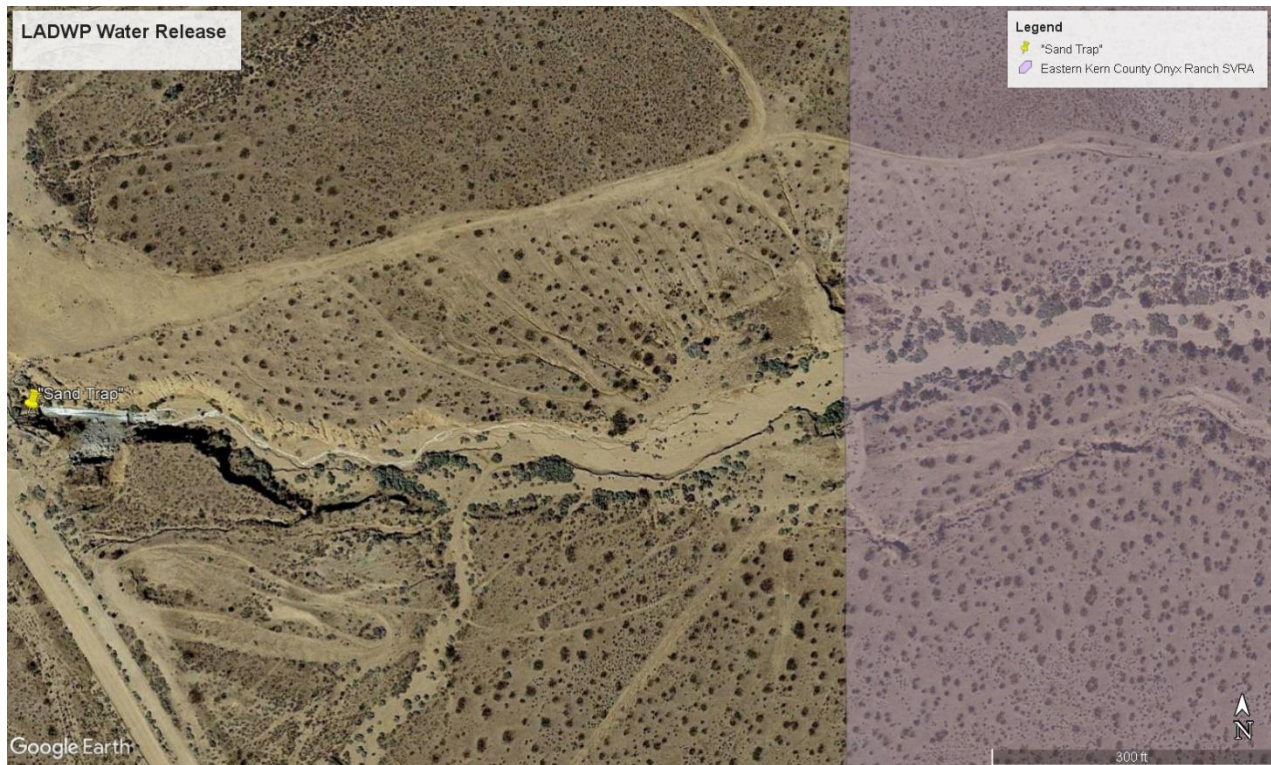
Figure 3. Aerial image showing LADWP water release site and proximity to Onyx SVRA.
