# Ocotillo Wells State Vehicular Recreation Area

## 2026 Soil Conservation Plan

California Department of Parks and Recreation  
Off-Highway Motor Vehicle Recreation Division and Natural Resources Division  
Ocotillo Wells District

June 2026

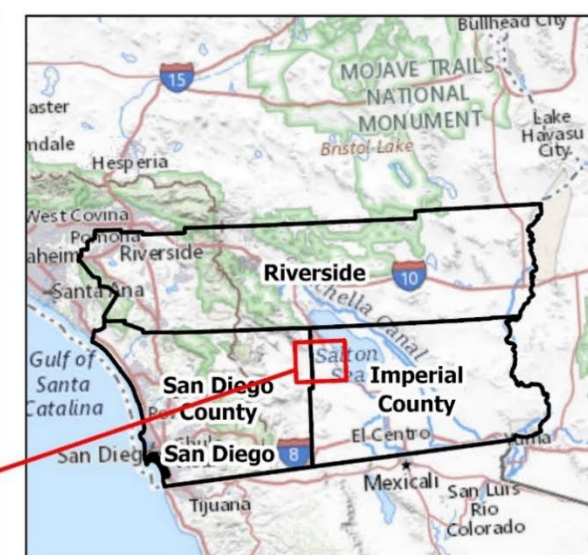
Figure 3. Regional location of Ocotillo Wells SVRA.

south, and Anza-Borrego Desert State Park® (ABDSP®) to the north and west. Approximately 17% of the SVRA is in San Diego County and the other 83% is in Imperial County (Figure 2). The closest urban areas are Brawley and El Centro, approximately 40 and 50 miles, respectively, to the southeast; and Indio, approximately 40 miles north of the SVRA. The area is accessible by regional transportation routes such as State Route (SR) 78 and SR-86 (Figure 3).
